Cultural Heritage Protection against Flooding

Miloš Drdáček, Luigia Binda, Insa Christiane Hennen, Christian Köpp, Luca G. Lanza and Rosemarie Helmerich

CHEF provides knowledge about flood protection of cultural heritage objects and directly supports the European Floods Directive by giving recommendations on how to assess the vulnerability of monuments. A comprehensive analysis of protective measures BEFORE, DURING and AFTER a flood has been carried out within the project, including technical and administrative measures. An overview of these measures is given, followed by recommendations on how to establish the most effective protective strategies.

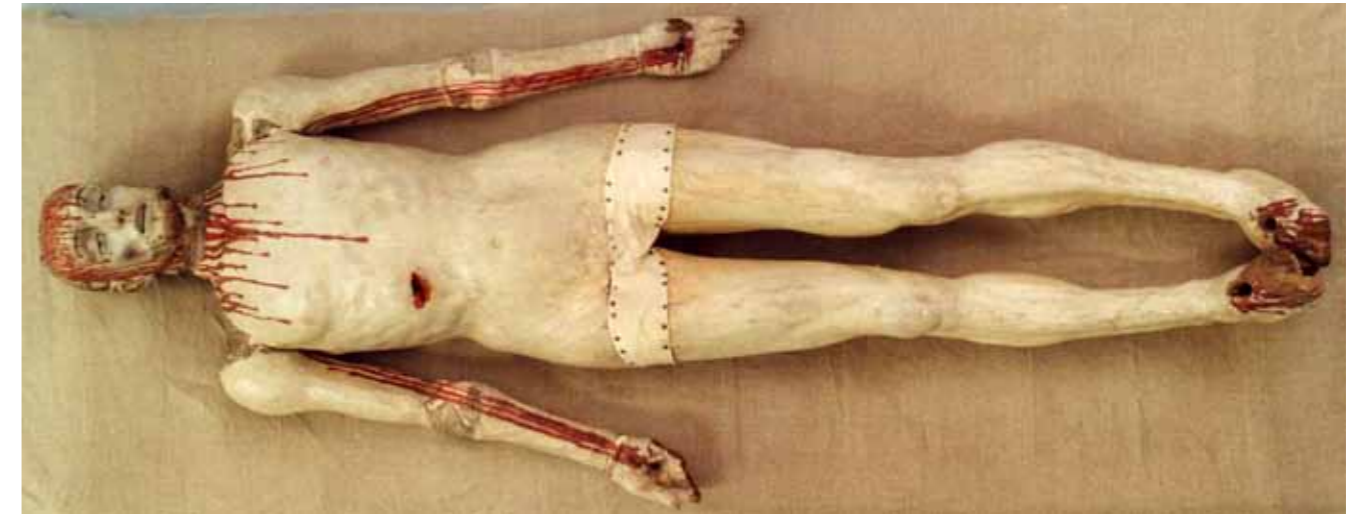
Figure 1.2.3.2: The Mirakelmann (church in Döbeln, Germany) during restoration after a flood. Source: Restauratorenegemeinschaft J. Bösenberg, E. Kless und F. Wosnitza

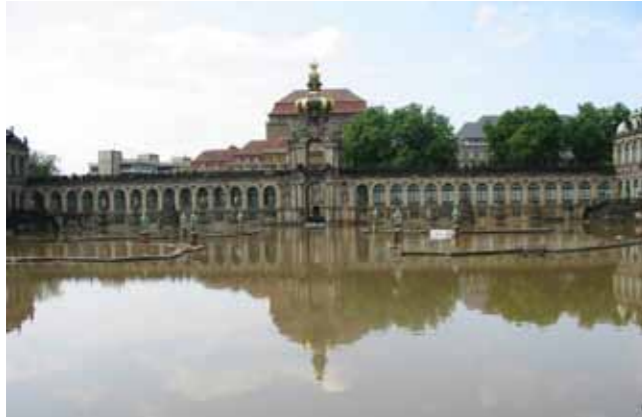
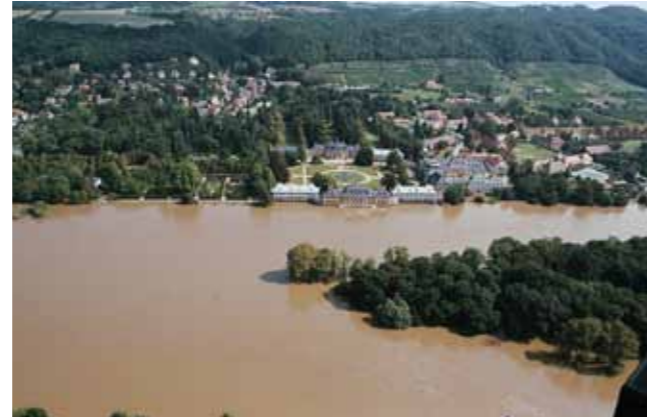
Figure 2.1.1: Flooded heritage site at the Dresden Zwinger (left) and landscape around Pillnitz Castle (right), Elbe flood 2002. Source: CHEF.

Damage to cultural heritage can occur on various scales: on rather small, movable archive museums and art collections as well as on buildings, historic or archaeological sites, gardens, parks, waterworks and entire landscapes (see Fig. 2.1.1). Damage to immovable cultural heritage due

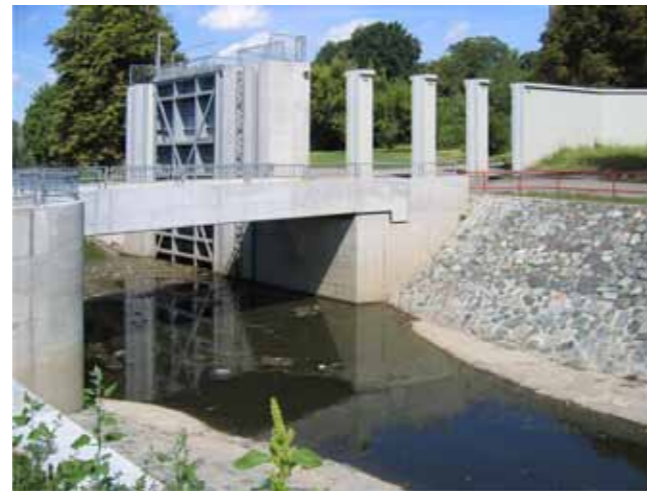
Figure 2.1.2.1 - Praha - Libeň separation of columns in Karlín public park. Source: T. Drdäcký.

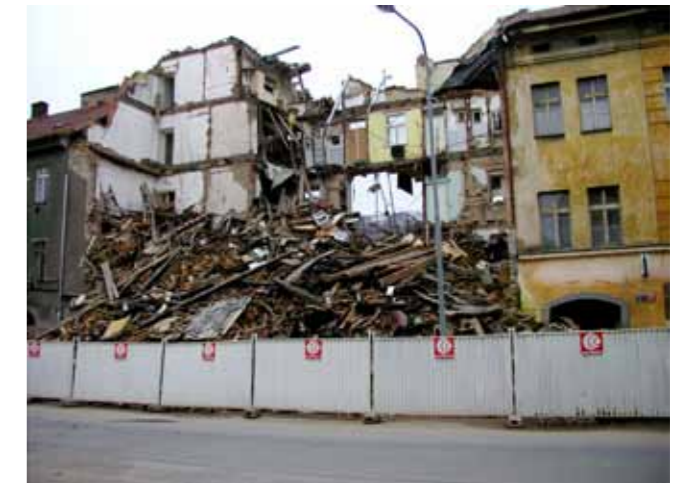
Figure 2.1.2.3: Collapsed building in Karlín. Source: NPÚ, Praha.

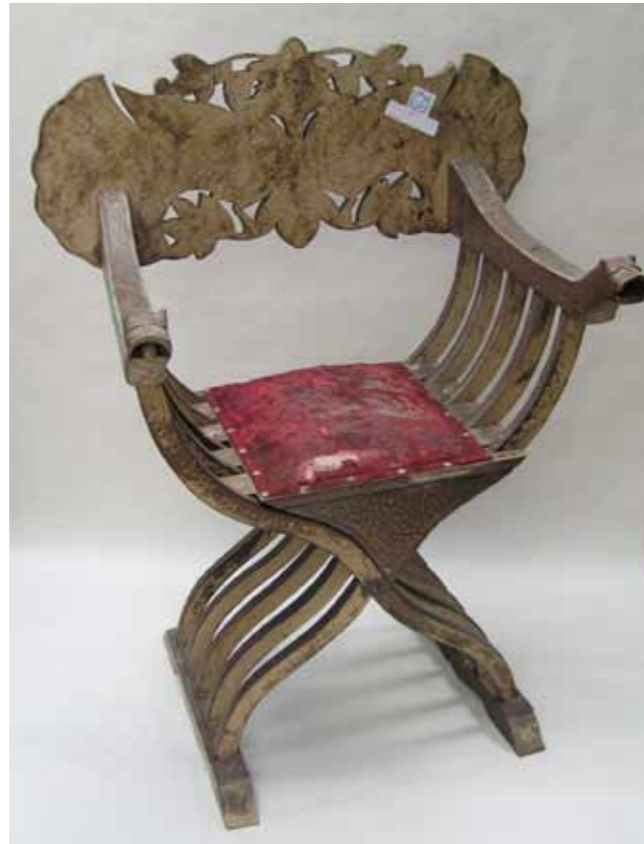
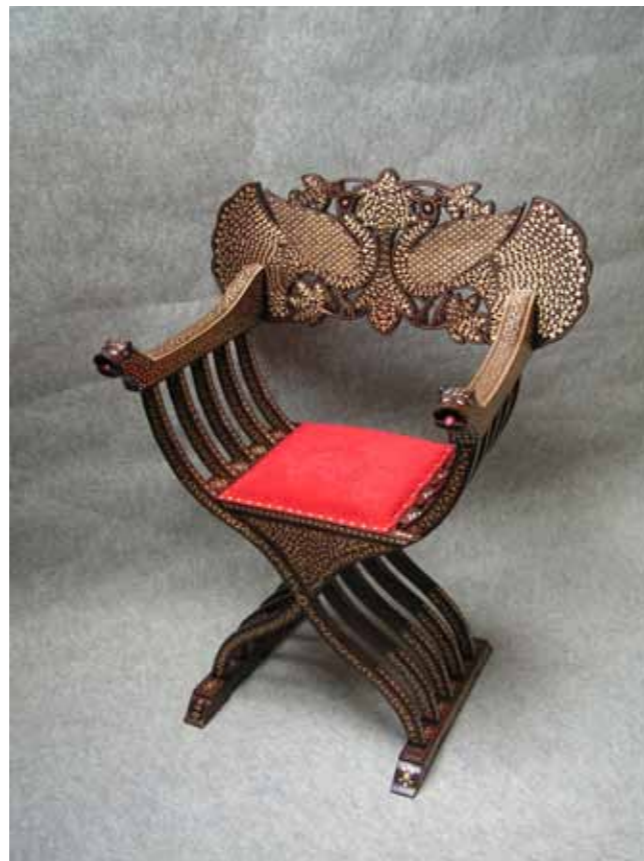
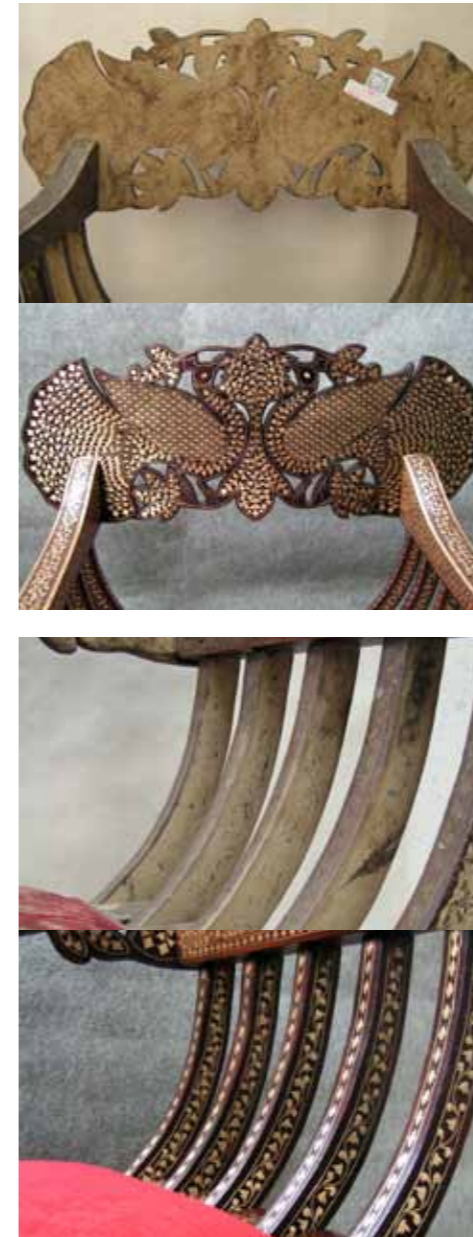
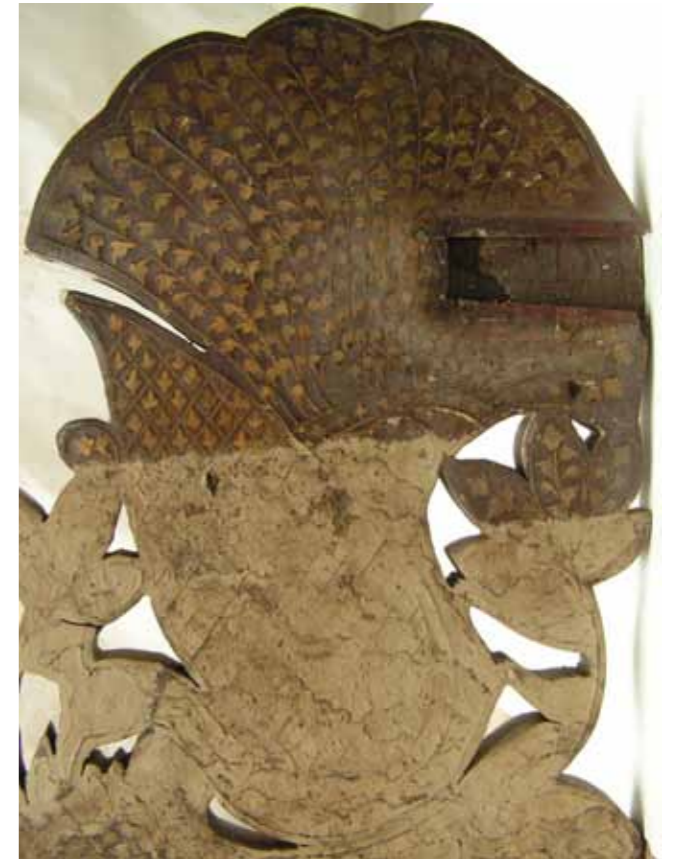
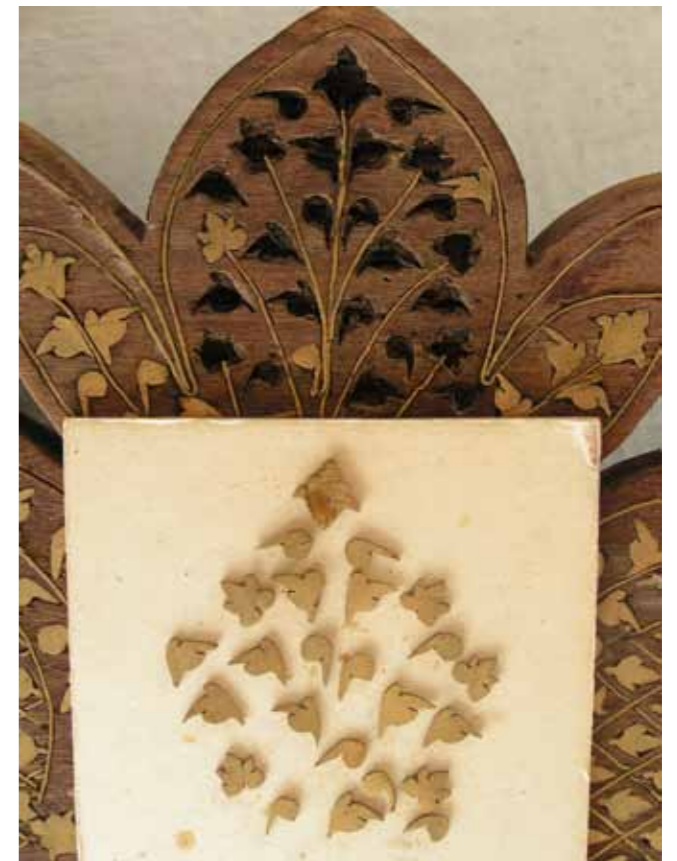
Figure 2.1.3.2: A Savonarola type folding armchair with brass incrustment from India, depository of the Náprstek Museum, Liběchov (Czech Republic). Savonarola arm chair damaged during Elbe flood 2002, before and after restoration (page 34), Pairs of details before (upper photograph) and after restoration (below). The damp absorbed by the wooden parts caused a considerable increase in relative humidity; the surface varnish (shellack) was badly damaged (partially converted to dust), mould, fungi; the wood was cracked, the brass incrustment has been loosened or lost; the upholstery has been affected by mould. Source: Petra Štefcová, Department of Preventive Conservation, National Museum, Prague (Czech Republic). Savonarola type folding armchair with brass incrustment, from India, depository of the Naprstek Museum, Liběchov (Czech Republic).

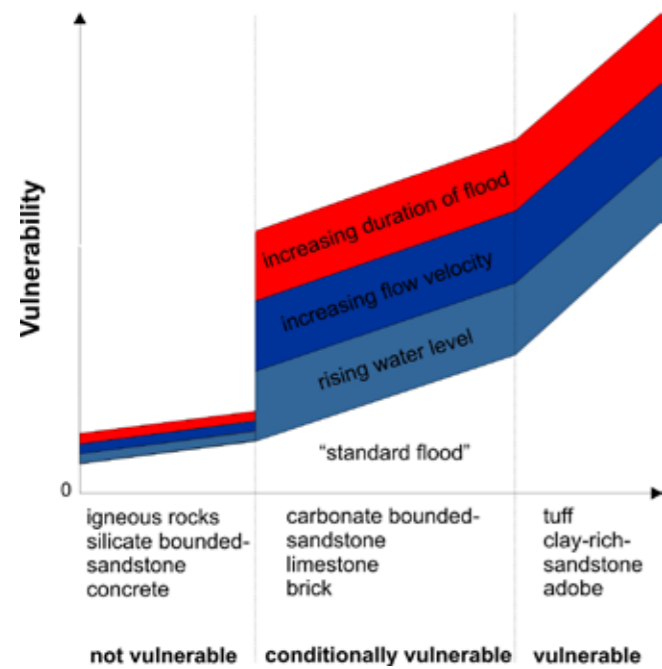
Figure 2.2.2: Vulnerability as the relation between building materials and flood characteristics. Source: IDK.

The following schematic diagram (see Fig. 2.2.2) depicts the relations between material and flood parameters and the influence of various flood parameters.

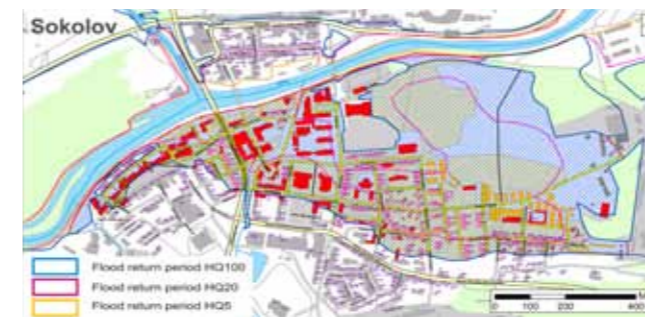
Figure 3.1.1.3: Sokolov CZ, flood risk defined as HQ5, HQ20, HQ100. Source: ITAM.

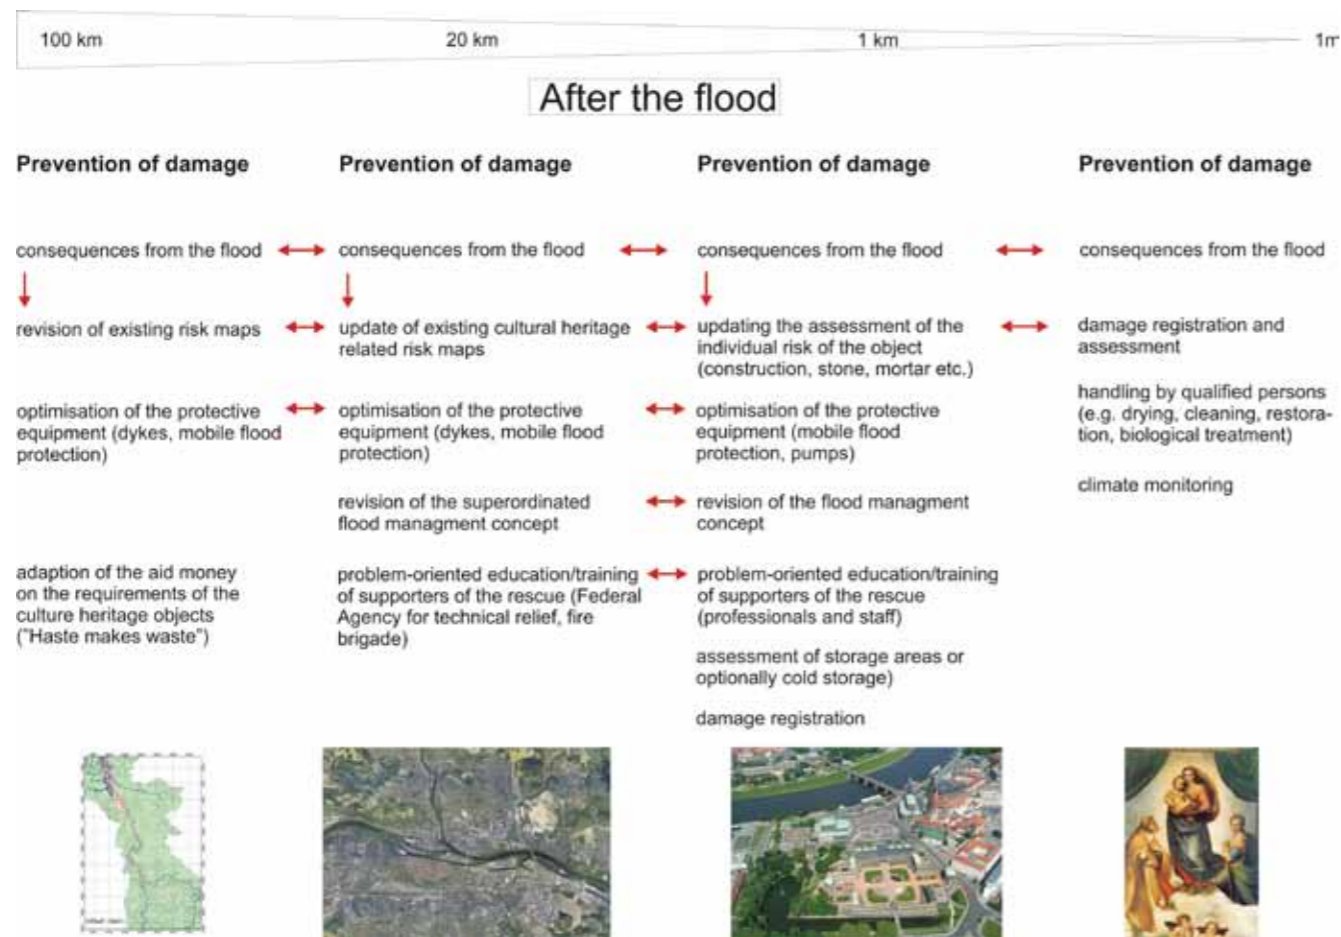
Figure 3.3.1: Rescue actions for prevention of damage after flood depending on the distance. Source: see figure 3.1.5.1.

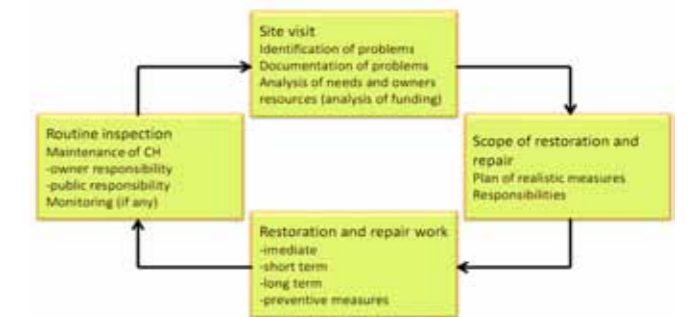
Figure 3.3.3.1: Planning for restoration and repair measures after flooding.

It is necessary to check protective measures planned for cultural heritage, such as structural measures or control systems, climate data loggers or climate control systems. According to the historical significance of the object, together with the risk, the vulnerability and the available resources, a plan for a routine survey, maintenance and an alert to-do plan for implementation in the event of further floods will help to provide preparedness for future hazards. Figure 3.3.3.1 gives an overview of the work flow.

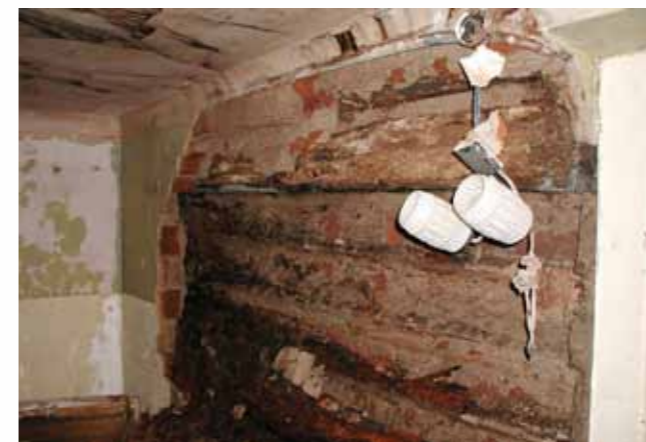
Figure 4.1.1.1 Log wall discovered after destruction of a brick veneer. Source: M. Drdäcký.

was not visible and not known, Fig. 4.1.1.1. The house was located on the bank of the Vltava River in a very flood-prone area, Fig. 4.1.1.2.

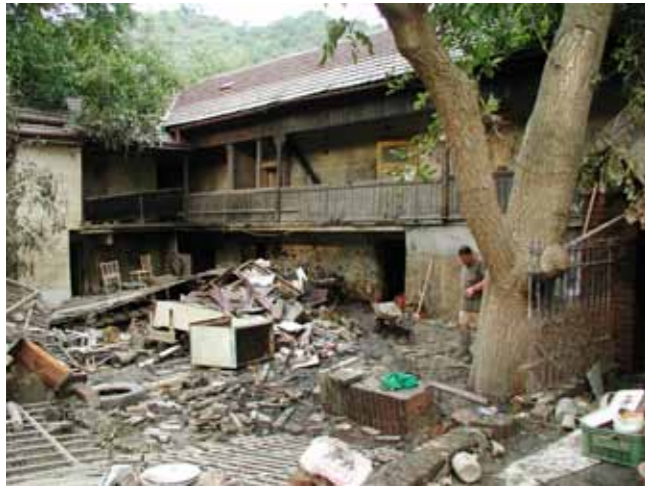
Figure 4.1.1.3: The high-water level is visible on the roof. Source: M. Drdäcký

the consequences of the flood for a historic structure. The house was almost totally immersed in water (Fig. 4.1.1.3.), and the stream in the vicinity of the house was probably quite strong during the flood event. This is illustrated by the number of small cottages that were floated into the garden of the house from quite far away (Fig. 4.1.1.4).

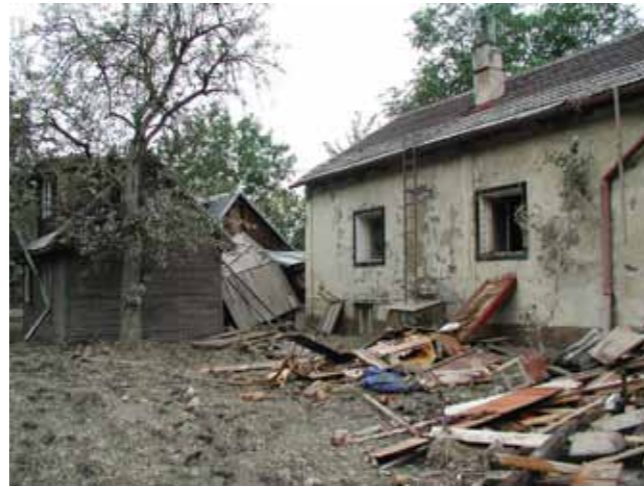
Figure 4.1.1.4: Wooden cottages floated into the garden. Source: M. Drdäcký

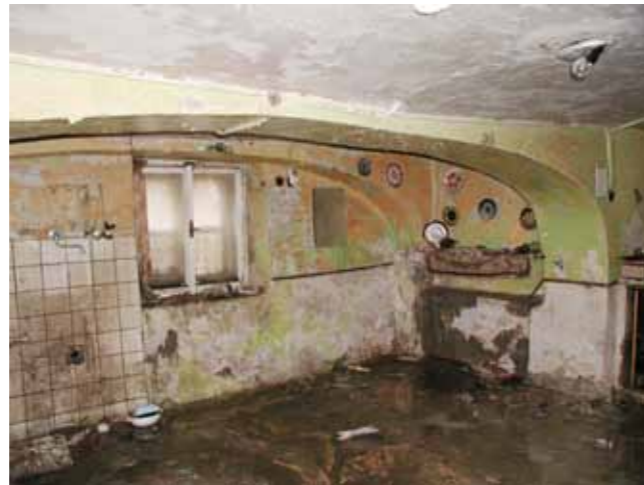
Figure 4.1.1.5: Deflected flat arch with an open crack decreasing the safety of the ceiling and requiring strengthening repairs. M. Drdäcký

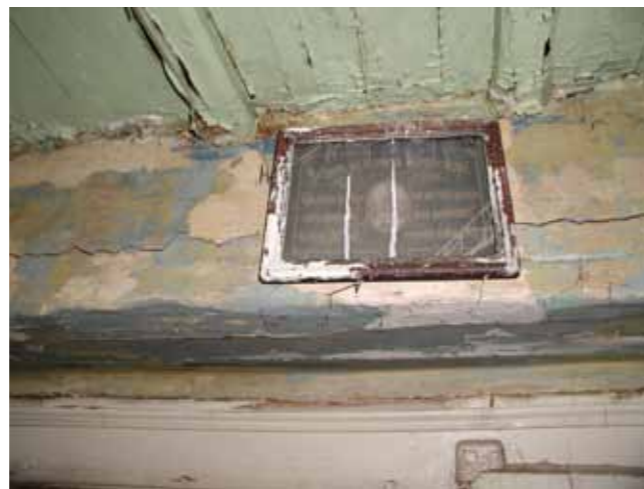
Figure 4.1.1.6: Timber joist ceiling with apparent deformation of its elements. Sources: M. Drdäcký.

It was recommended to clean the attics from mud and all other infill materials in order to allow proper drying, which could be further improved by opening the masonry around the joist supports, Fig. 4.1.1.6. The timber joists had to be dried after removing all lime wash paints and mortar fillings, in cooperation with restorers. In such cases, this is indispensable. Though the house survived the flood, with serious but repairable damage, like many other houses in Prague it did not survive the subsequent development pressure. The owner took advantage of the flood damage and gained permission to demolish this protected building.

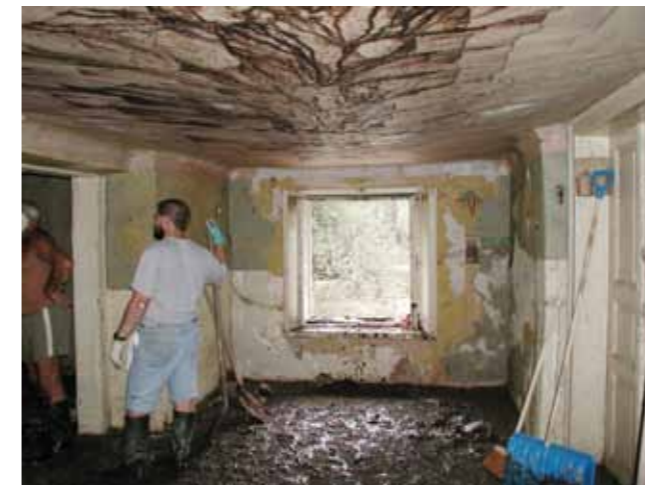
Figure 4.1.1.8: The exceeded deflection of the timber ceiling is well visible, as is the soiling of the building with mud. Sources: M. Drdäcký.

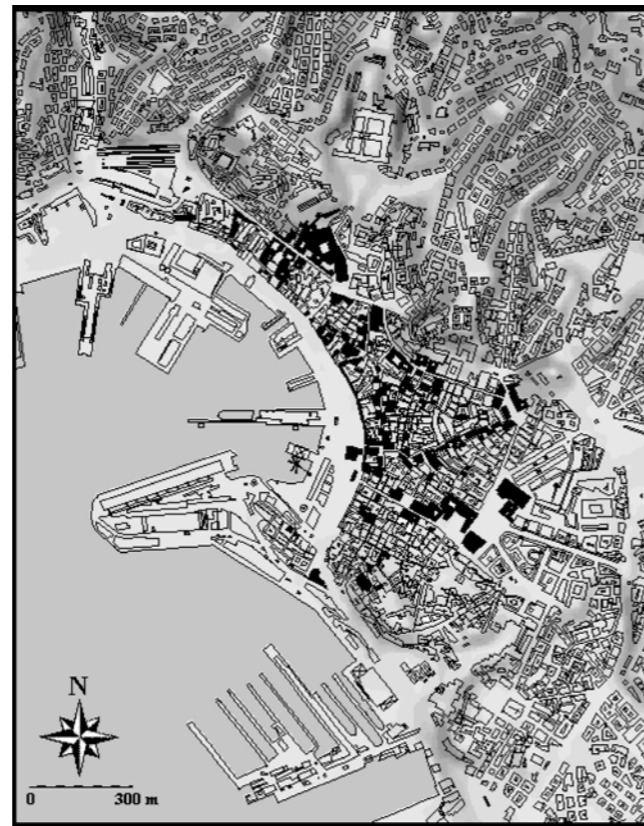
Figure 4.2.1.4: Historically flooded sites and a map of cultural heritage at risk in Genoa. Source: CRUIE.

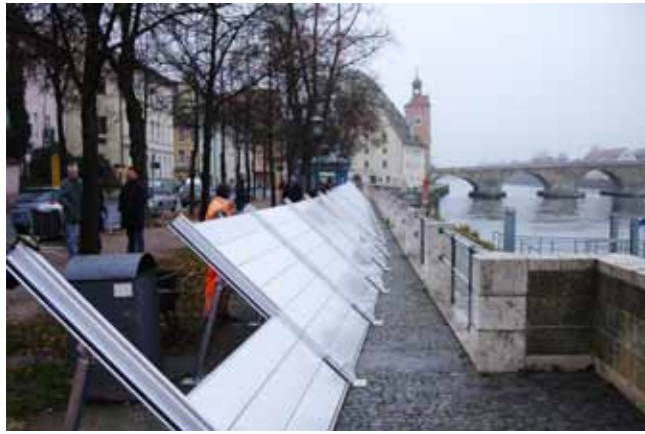
Figure 4.2.2.2: IBS K-system on the historic Danube promenade. Source: Xaver Storr.

For example, IBS (Industrial Barriers and Fire Protection Technology) is the company that developed the mobile flood protection walls. The so-called K-system is an abbreviation for Catastrophe Protection System (German:

Katastrophe = catastrophe) (Fig. 4.2.2.2 and 4.2.2.3). This system does not require any preparatory structural measures on asphalt up to a flood height of 1.30 m and can therefore be applied flexibly in different locations (length 1300 m, area 1700 m<sup>2</sup>).

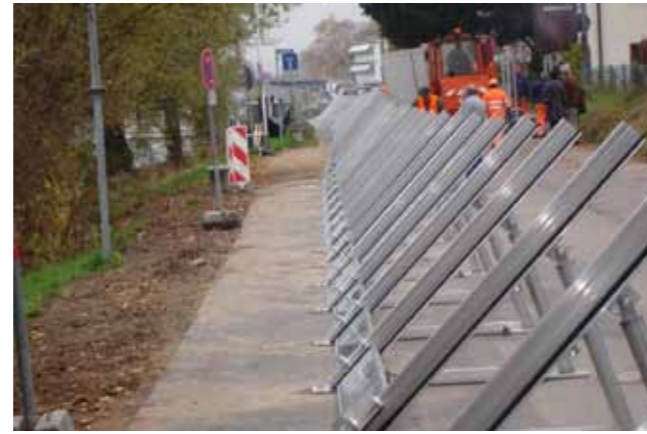
Figure 4.2.2.3: IBS K-system, K-rack fixed with a peg on the pavement (water-side). Source: Xaver Storr.

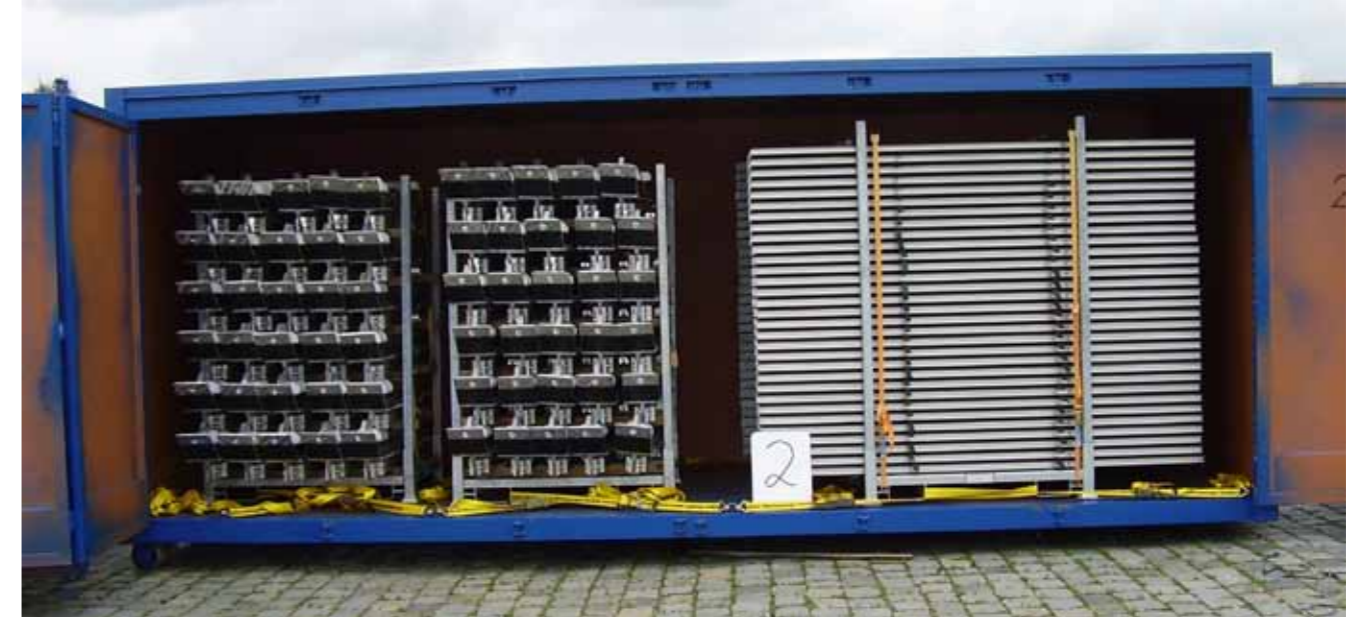
Figure 4.2.2.4: IBS K-system, transport container with side-opening doors. Source: Xaver Storr.

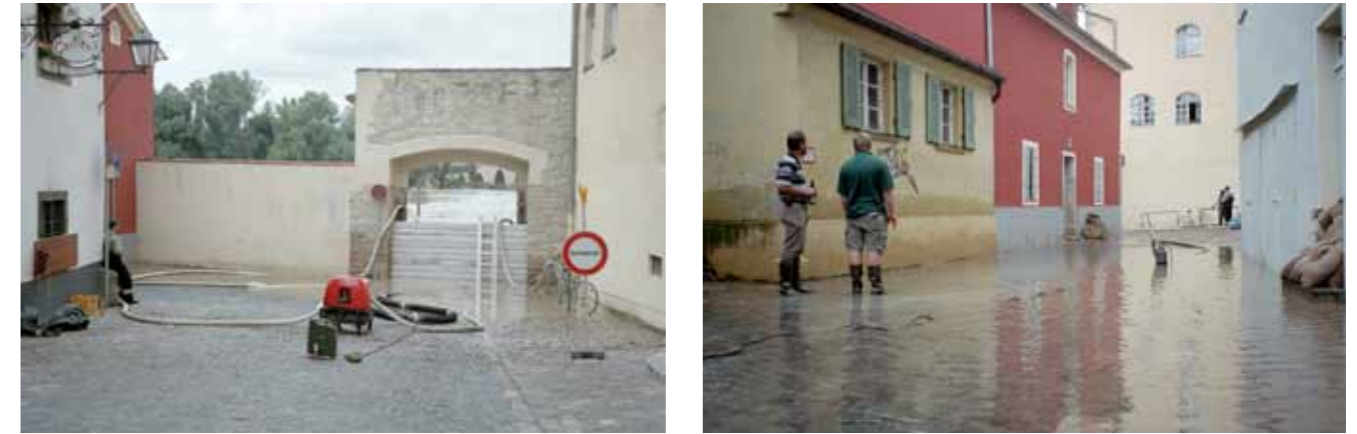
Figure 4.2.2.6 Pictures of the flood in Regensburg in August 2002, with special regard to flood blocking measures. Source: Andy Schwierskott.

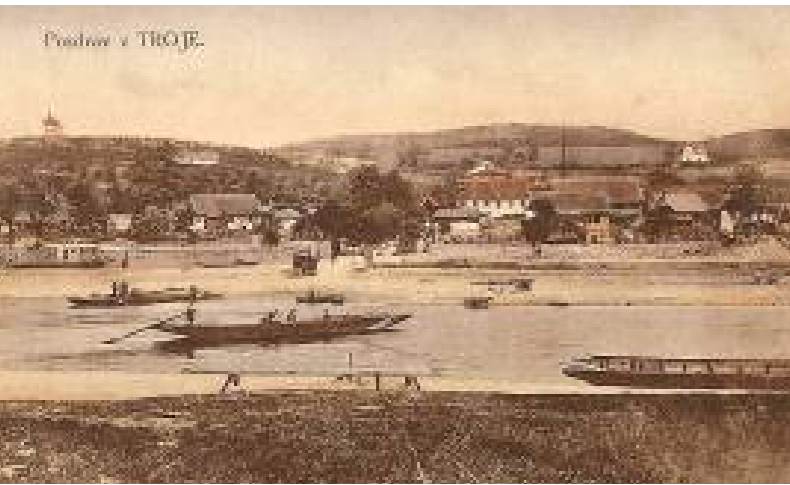
Figure 4.2.3.1: Historic relation to the river, and the original protective walls. Source: Municipality of Troja.

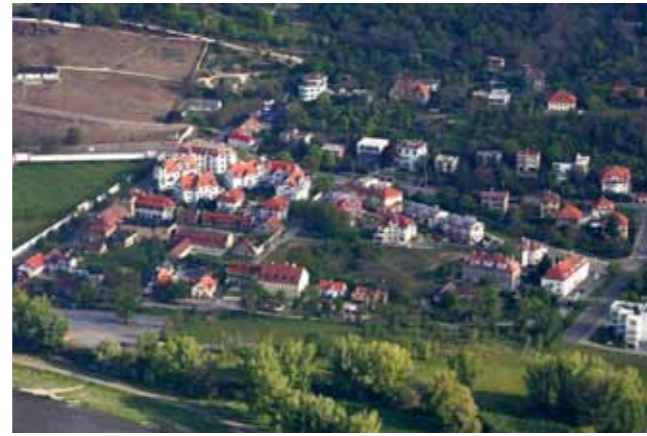
Figure 4.2.3.6: The original situation and the line of the new dike. Source: Municipality of Troja.

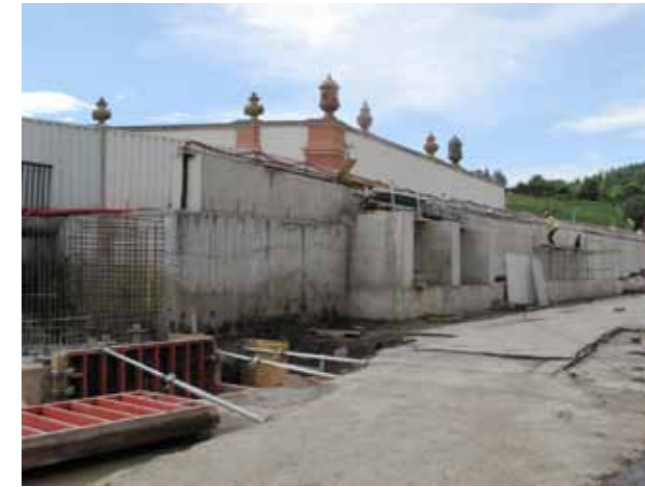
Figure 4.2.3.7: Difference between the scale and detail of the historic wall of Troja Chateau with decorative terracottas and the new concrete wall. Source: T. Drdäcký.

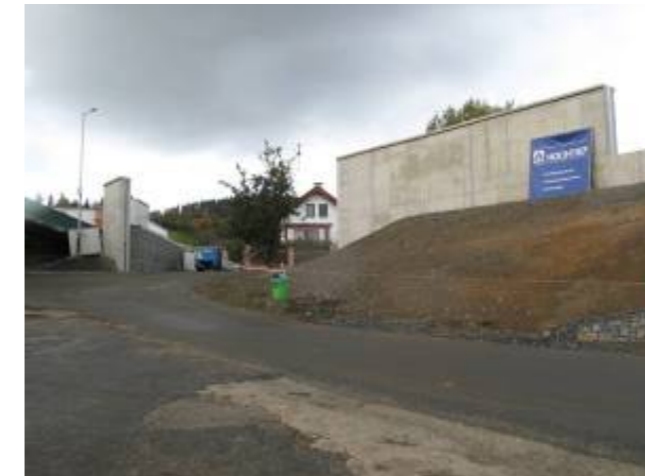
Figure 4.2.3.9: Concrete wall up to 6 m in height. Source: T. Drdäcký.

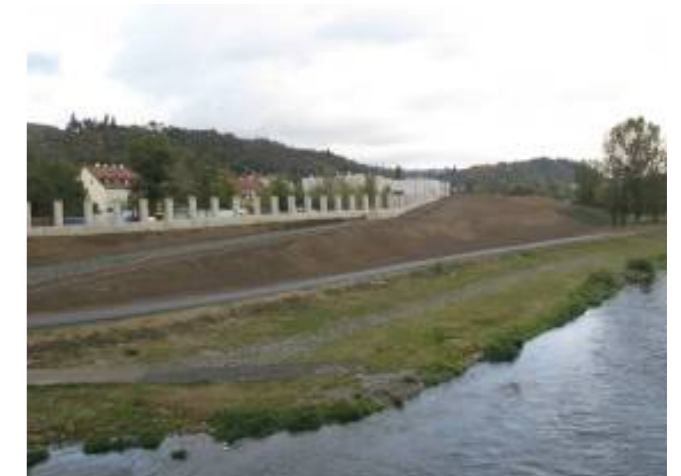
Figure 4.2.3.10: Originally designed as a solid wall - modified after pressure from LA, Source: T. Drdäcký.

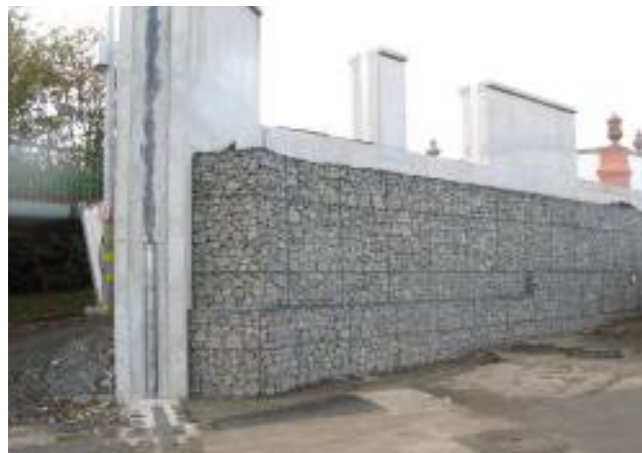
Figure 4.2.3.13: Detail of the finished concrete wall with gabions. Source: T. Drdäcký.

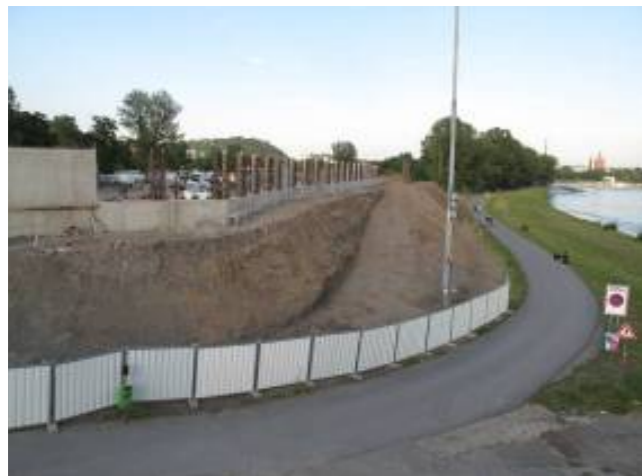
Figure 4.2.3.15: New mound and wall, compared to the human scale. Source: T. Drdäcký.

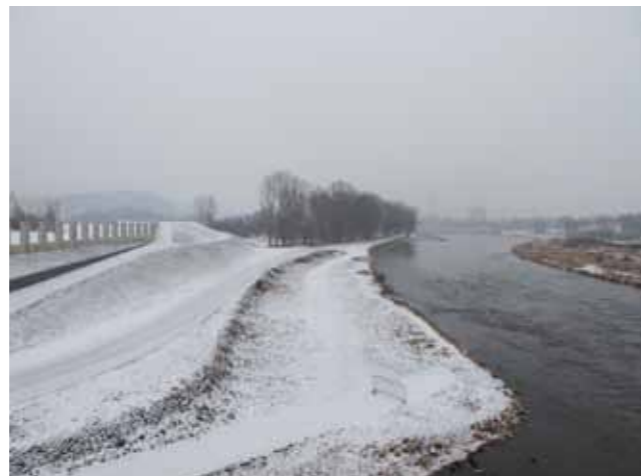
Figure 4.2.3.16: New mound and wall separating the area next to the river from the inner part of the district. Source: T. Drdäcký.

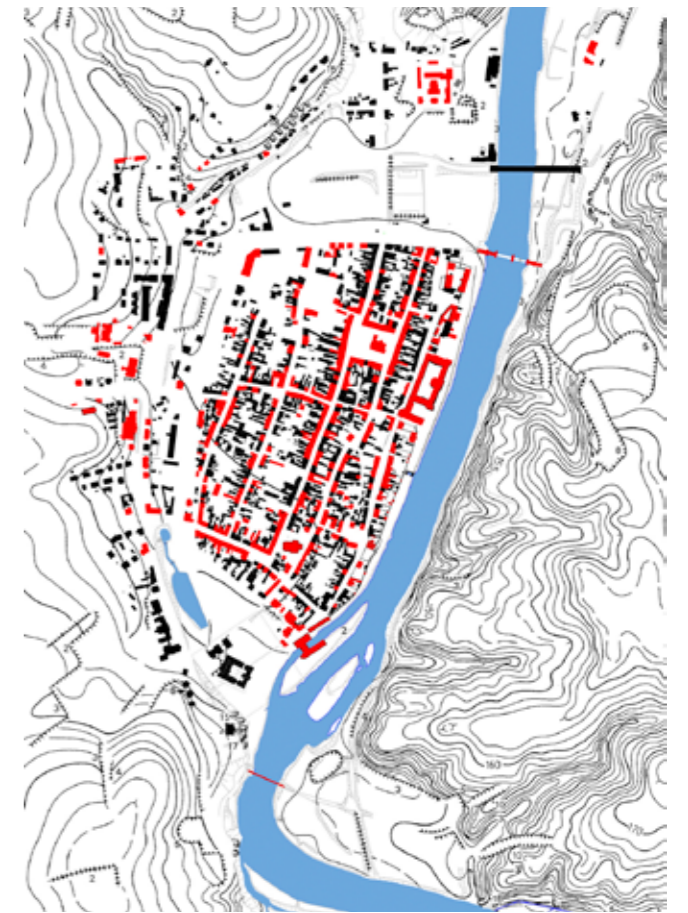
Figure 4.2.5.1: Town and river in their geomorphological setting, listed buildings marked in red. Source: T. Will, H. Lieske.

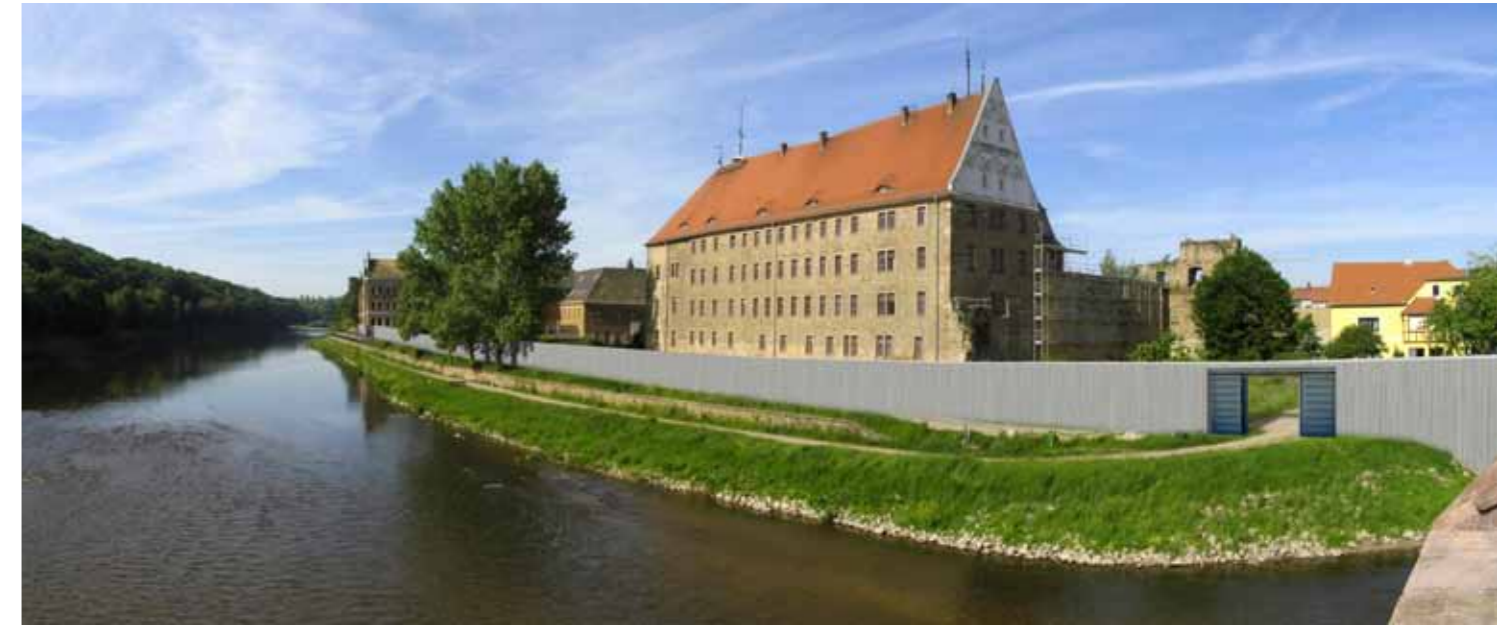
Figure 4.2.5.3: The Mulde River, the castle, the flood protection wall, preliminary proposal by the Dam Authority. Source: T. Will, H. Lieske.

The arched bridge by the famous Baroque architect M. D. Pöppelmann marks the main entrance to the town, adjacent to the castle. A monolithic concrete wall, as suggested initially, would certainly spoil the sense of place here. (Fig. 4.2.5.3) A subsequent proposal to set the flood protection back from the river proved, however, to cause too much interference with the archaeological site at the location of the former castle moat. The final solution integrates the flood protection wall with a new promenade approaching the historic bridge (now restricted to pedestrians), thus defining a confined urban space that can be developed into an attractive new plaza. (Fig. 4.2.5.7)

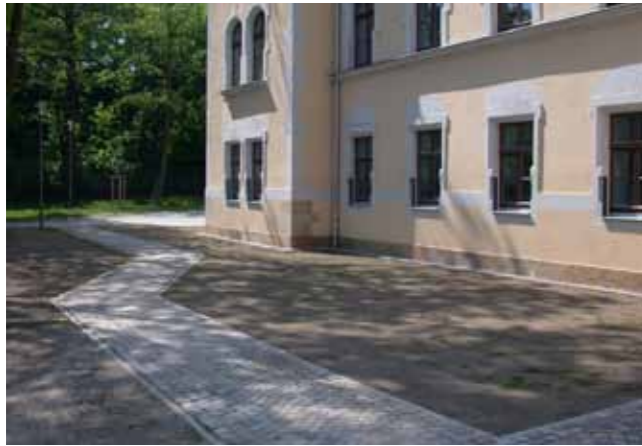
Figure 4.2.5.5: District Administration Building, flood protection integrated into the historic building, 2009 (note the U-profiles in the window reveals, with covers temporarily removed, to hold stop logs). Source: T. Will, H. Lieske.

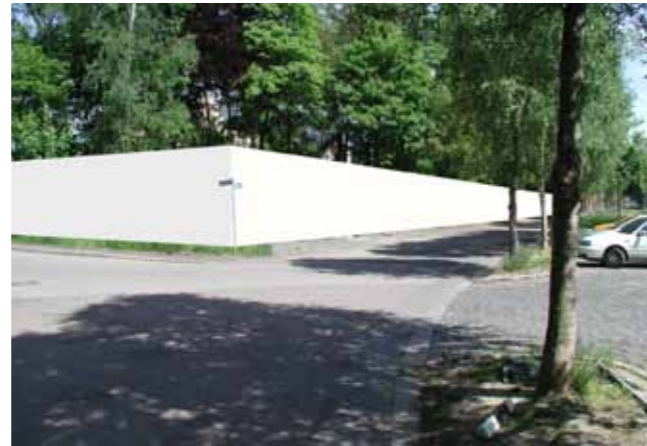
Figure 4.2.5.6: Site of the District Administration Building, monolithic flood protection wall, preliminary planning stage, photomontage. Source: T. Will, H. Lieske.

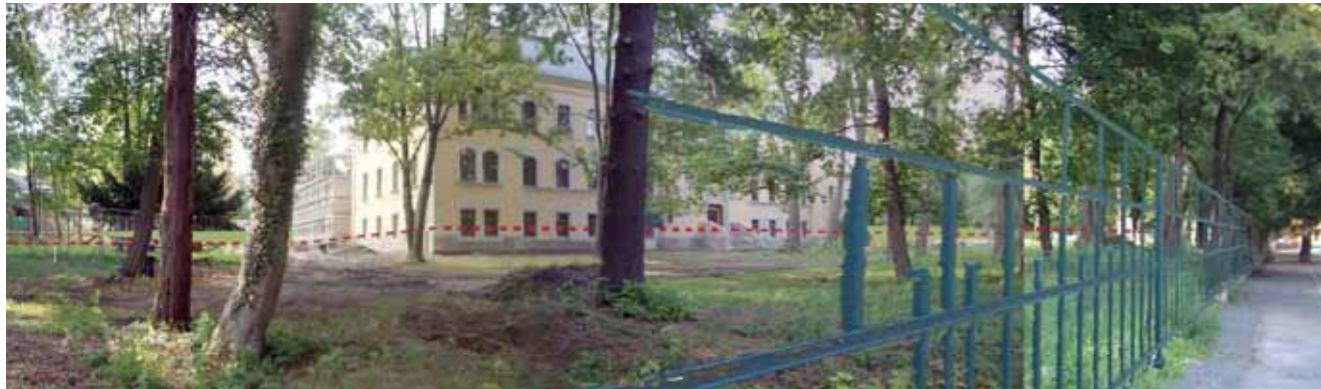
Figure 4.2.5.7: Site of the District Administration Building, dotted line indicating flood protection integrated into the historic building. Integrated planning proposal, photomontage. Source: T. Will, H. Lieske.

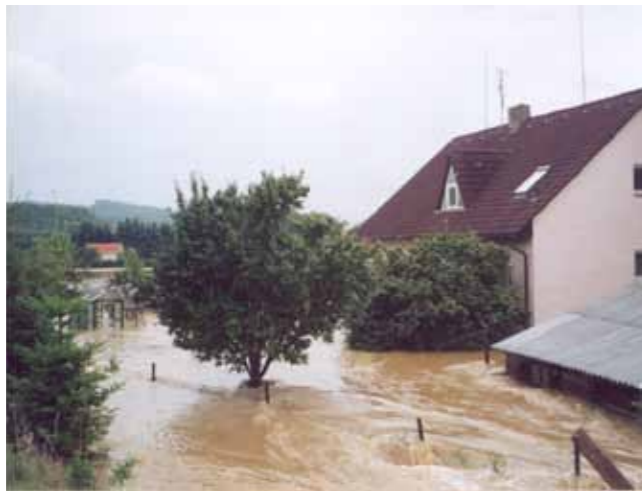
Figure 4.2.7.1: In some places the water rose to 1,7 m. Source: Photoarchive Švihov.

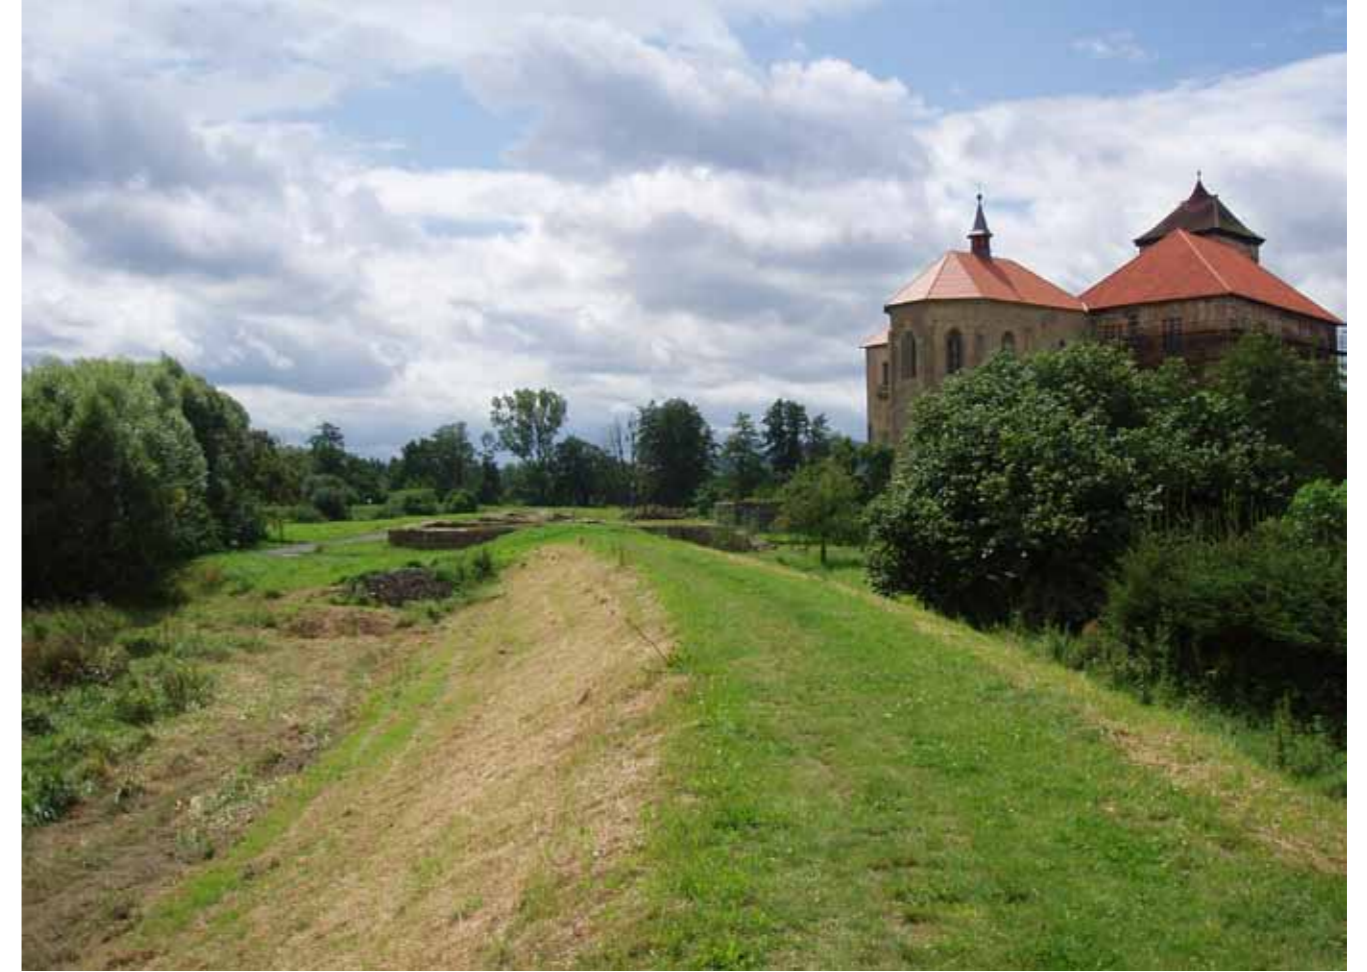
Figure 4.2.7.3: Protective rampart. Source: Photoarchive Švihov.

The suggested measures included the erection of a protective rampart on the right side of the water channel, passing round the castle. The original suggestion was for a terrain barrier in the close vicinity of the castle. This would

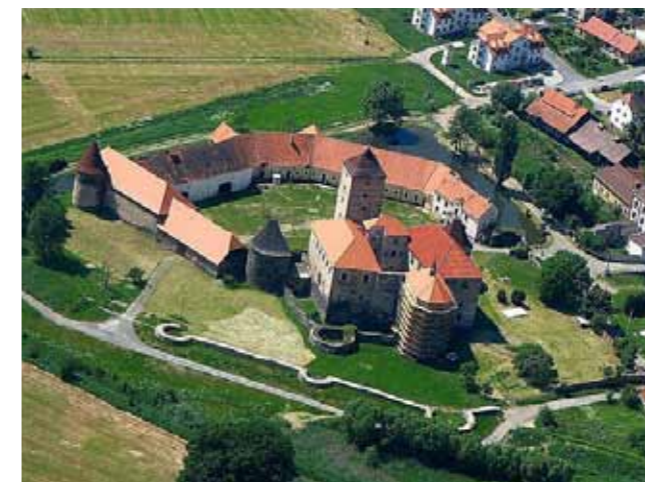
Figure 4.2.7.4: Reconstruction of the fortification wall. Source: A. Hříbal.

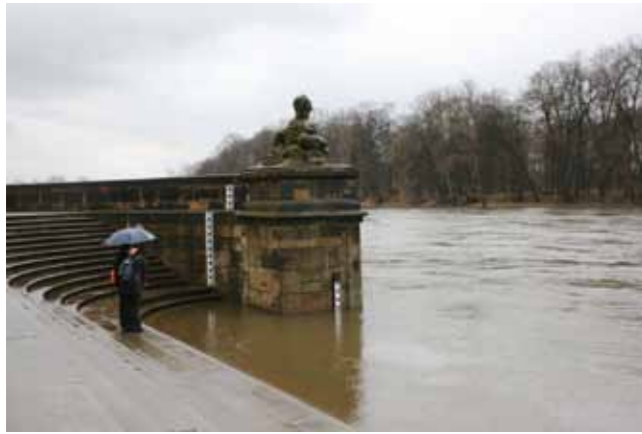
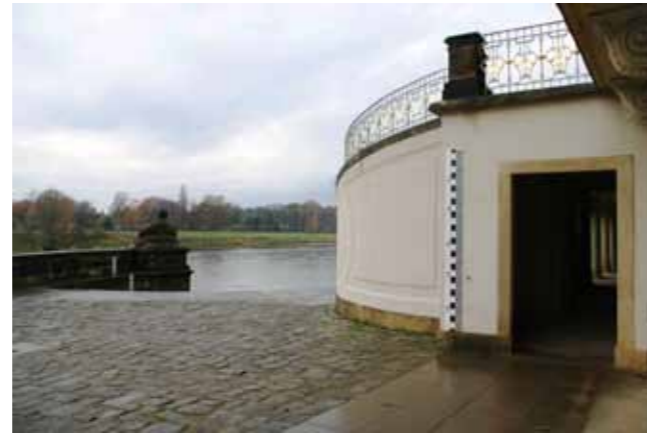
Figure 4.3.1.3: Water gauge at the Wasserpalais. Source: IDK.

Figure 4.3.1.4: Water gauge at the Wasserpalais. Source: IDK.

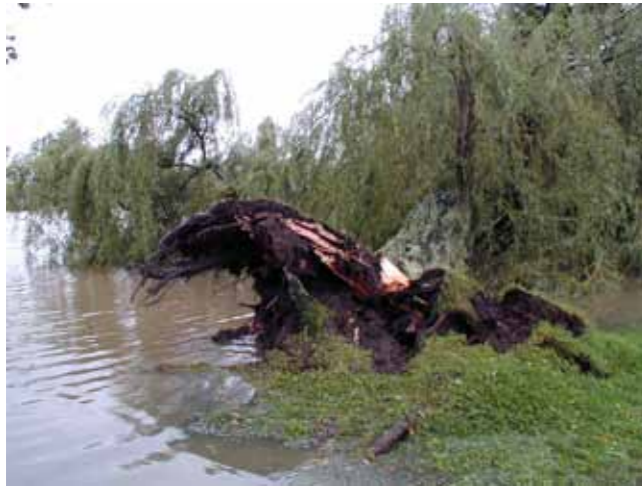
Figure 4.3.2.2: Uprooted aged willow. Source: Jiří Bláha.

Damage to trees can be divided into two types – damage that is visible immediately after the water level decreases, and damage that shows up later. The first category includes mechanical and static damage, for example damage to tree bark, exposed roots, etc. Changes that are not visible tend to be more serious. Trees usually do not perish immediately after a calamity but react after several months or even years. Destruction of fully-grown trees is a very serious long-term effect, and can change the whole appearance of the park for decades.

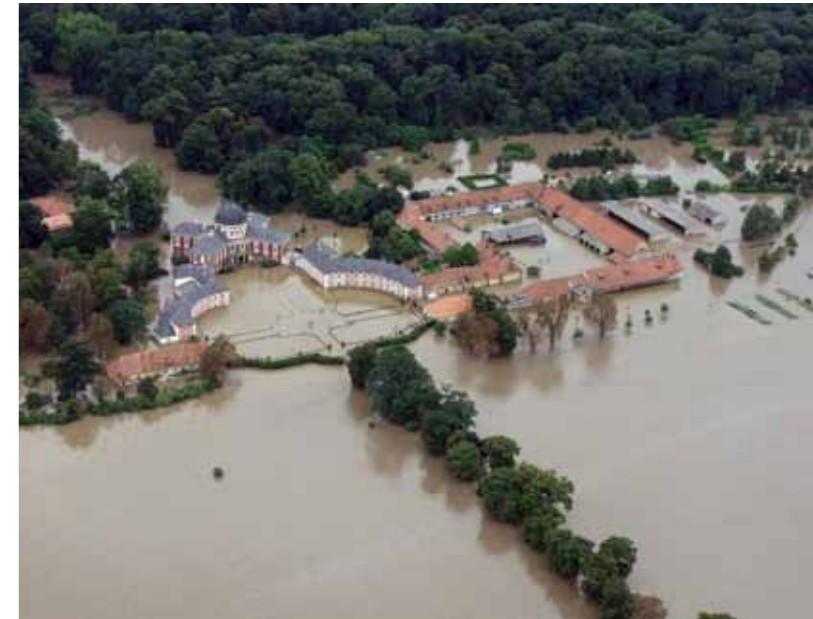
Figure 4.3.3.1: Veltrusy Castle during the flood culmination. Source: [http://www.radio.cz/en/article/108349/pictures/zamky/veltrusy\\_povodne.jpg](http://www.radio.cz/en/article/108349/pictures/zamky/veltrusy_povodne.jpg).

In 2002, the castle survived an exceptionally high flood. The water reached a height of 3,5 m in the park and in some of the structures, and this was accompanied by a quite strong water stream velocity. The maximum flow volume attained in Prague was 5500 m<sup>3</sup>s<sup>-1</sup>, which corresponds to a so-called 500-year flood. The area was flooded for about

nine days, Fig. 4.3.3.1. (Photographs Zděnek Rieger)

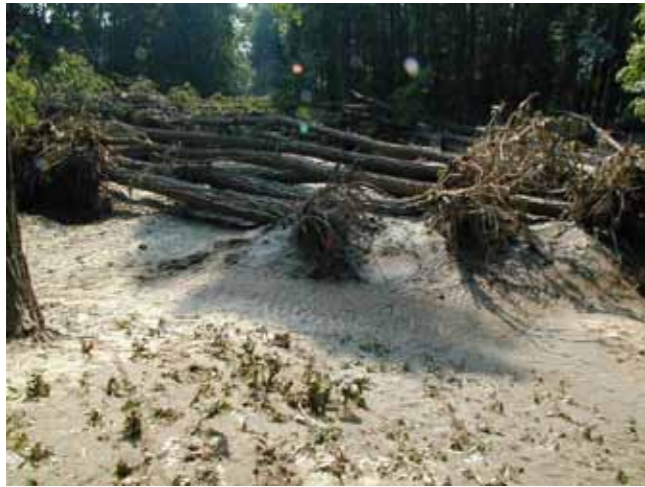
Figure 4.3.3.3: Fallen trees in the landscape park. Source: Milan Dropka.
