Cultural Heritage Protection against Flooding

Miloš Drdáček, Luigia Binda, Insa Christiane Hennen, Christian Köpp, Luca G. Lanza and Rosemarie Helmerich

CHEF provides knowledge about flood protection of cultural heritage objects and directly supports the European Floods Directive by giving recommendations on how to assess the vulnerability of monuments. A comprehensive analysis of protective measures BEFORE, DURING and AFTER a flood has been carried out within the project, including technical and administrative measures. An overview of these measures is given, followed by recommendations on how to establish the most effective protective strategies.

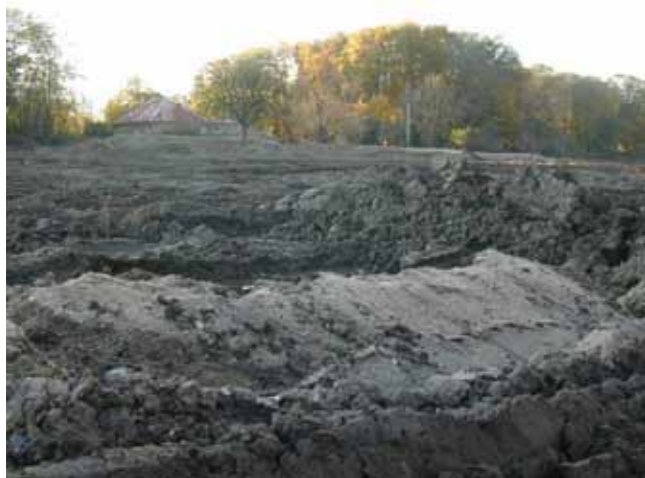
Figure 4.3.3.2: Sand and gravel transported into the park. Source: Milan Dropka.

The total cost of the damage was estimated at CZK 250 million (about EUR 10 million). The stream broke through the protective dike along the river, and devastated the landscape over an area of about 30 ha, on which sand and gravel was dumped to a height of up to 2 m, see Fig. 4.2.b. In the park, the water stream undermined or felled about 1000 trees and damaged thousands more. There will be more losses in future, due to delayed effects of the flood, Fig. 4.3.3.3. All roads and paths in the park were damaged or destroyed. The piles of objects that drifted on to the fields contained many dangerous or unknown agents, Fig. 4.3.3.4.

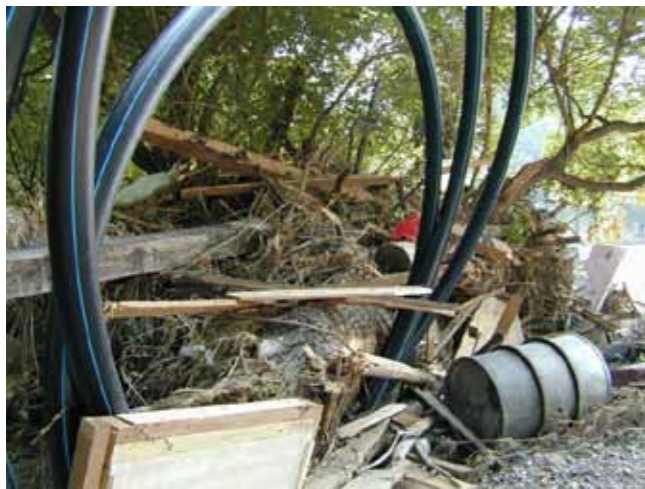
Figure 4.3.3.4: Dangerous debris deposited in the forest. Source: Milan Dropka.

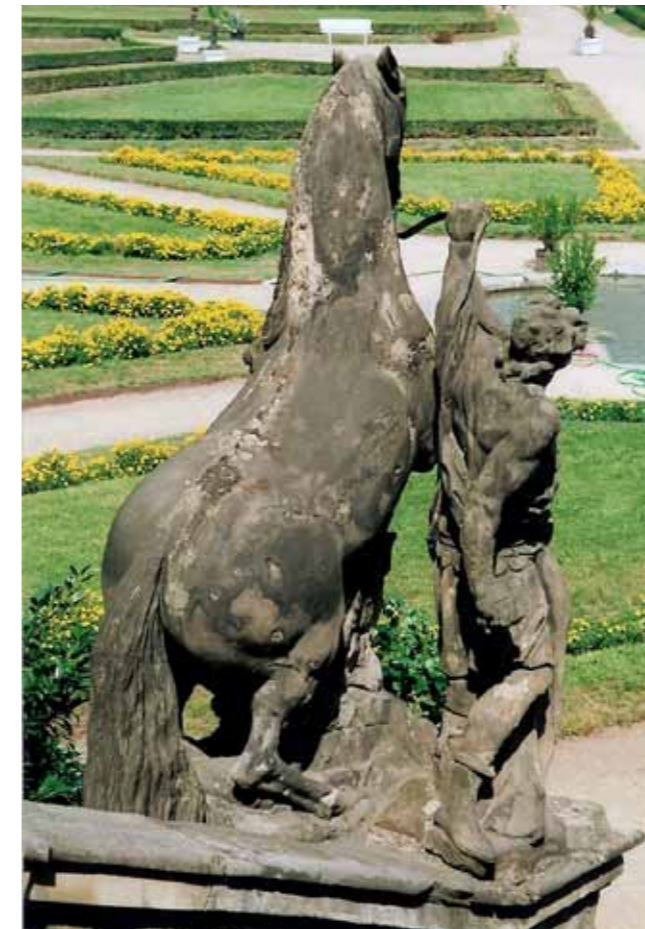
Figure 4.3.3.5: Incorrectly restored sandstone sculptures. Source: Vojtěch Adamec.

component), detachment and exfoliation. On the surface of the stone monuments, many sections repaired with mortar in the past were of different quality and colour. No water soluble salts were detected, apart from gypsum on the surface.

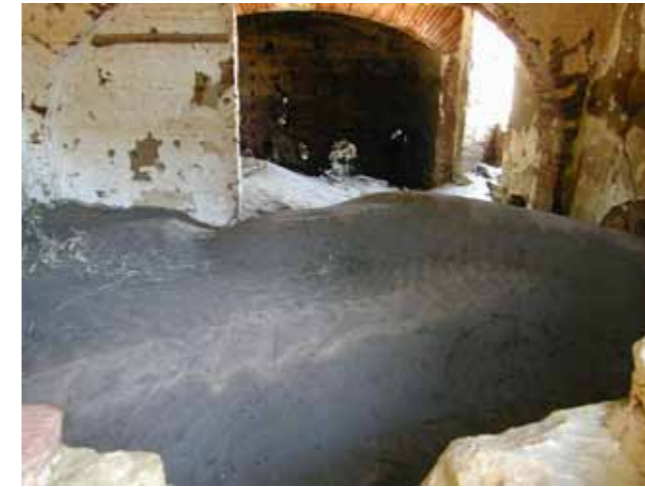
Figure 4.3.3.7: Sand piles inside the gamekeeper's lodge. Source: Milan Dropka.

Cleaning everything required a substantial amount of work, and would not have been possible without massive help from the army, using their heavy excavation and transportation vehicles. A lot of material also had to be removed manually from the interiors of the buildings, Fig. 4.3.3.7.

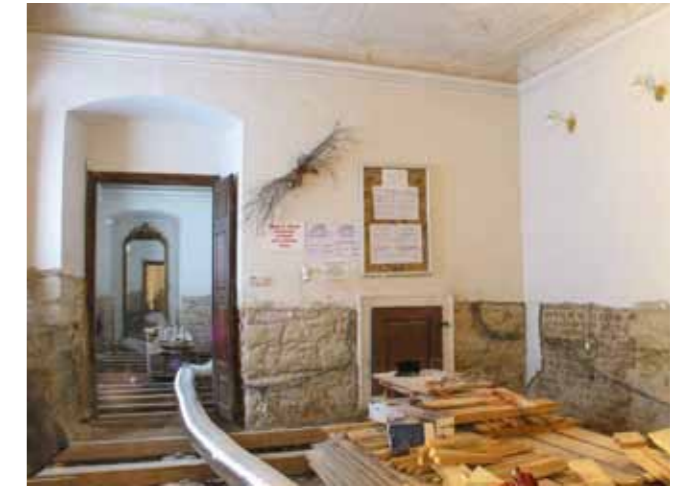
Figure 4.3.3.8: Drying and ventilation of the palace masonry walls. Source: Milan Dropka.

The palace walls were left to dry naturally, with the support of forced ventilation and only slight tempering to avoid freezing during the winter period, Fig. 4.3.3.8. The plaster was removed only in minor areas, partly because of the valuable wall decorations (frescos and mosaics), partly due to the assumption that plastering helps to maintain the integrity of the adobe bricks that had been inserted into the mixed burnt brick and stone masonry.

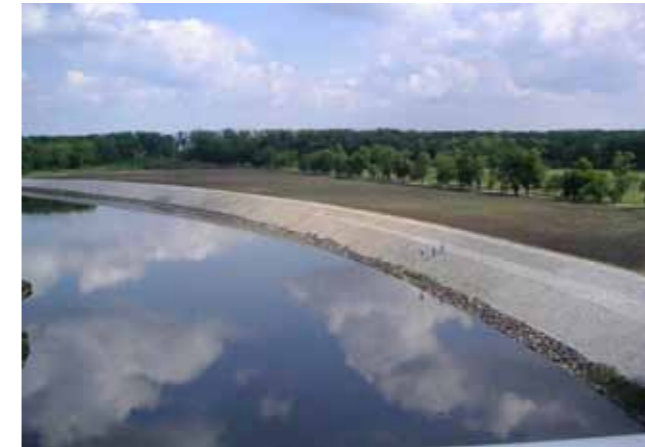
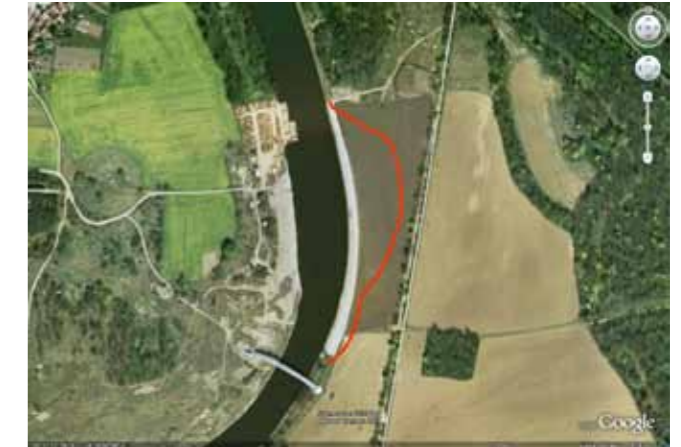
Figure 4.3.3.9: The new protection levée along the river, and the area which was washed away (red line). Source: Ján Bradovka.

A completely new protection levee 450 m in length had to be built along the river, and an area of about 30 ha needed to be restored. Fig. 4.3.3.9. New dikes were built near the Laudon pavilion, and also a channel bridge. Gaps in the foundations and masonry of small bridges were either injected with mortar or walled up.

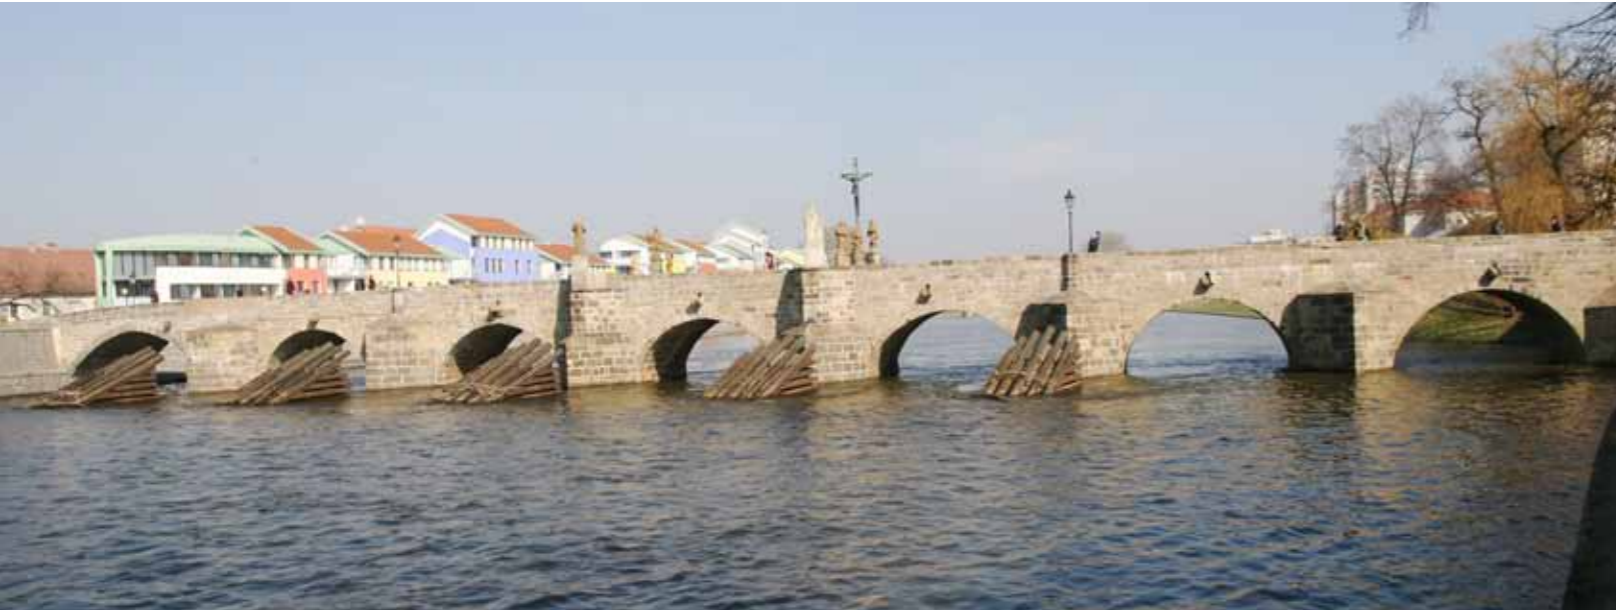
Figure 4.4.1.1: Stone bridge in Písek after restoration following the disastrous flood in 2002. Source: M. Drdäcký.

The Stone Bridge over the Otava River in Písek was built in the second half of the 13th century and it is still in use. This is the second oldest stone bridge built in Bohemia and the oldest preserved bridge in Bohemia. At the present time, the Stone Bridge has seven vaulted arches (six circular arches and one segmental arch), six inner pillars and one abutment (on the right bank). Originally, the bridge had one (or two?) more left bank spans and there were bridge towers on both ends of the bridge (Fig. 4.4.1.1). The segmental arch replaced the two original

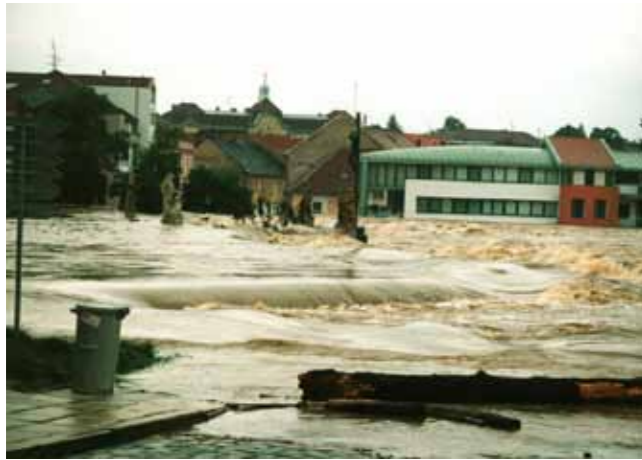
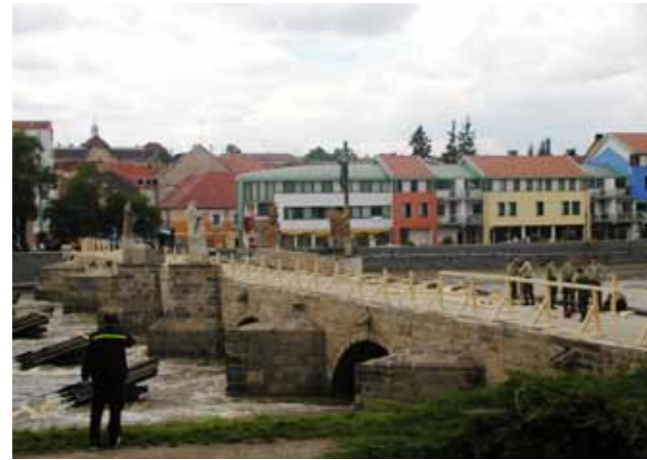
Figure 4.4.1.2: Stone Bridge under culminating water on 13 August 2002 and with a temporary timber rail after the 2002 flood. Source: Petr Brož (cz .Wikipedia/Stone Bridge Písek, for use in the public domain).

Persistent rains in August 2002 gave rise to the biggest and most disastrous flood ever recorded on the Otava in Písek. The water culminated on August 13th, and the highest measured flow rate (further measurement was not possible) was 1,400 m<sup>3</sup>/s; the level reached a height of 904 cm above normal. From an approximate extrapolation on the  $Q_n$  line, it can be considered a more than 100-year return period flood. By the end, the water in the river reached 2 m above the bridge road (Fig. 4.4.1.2). The

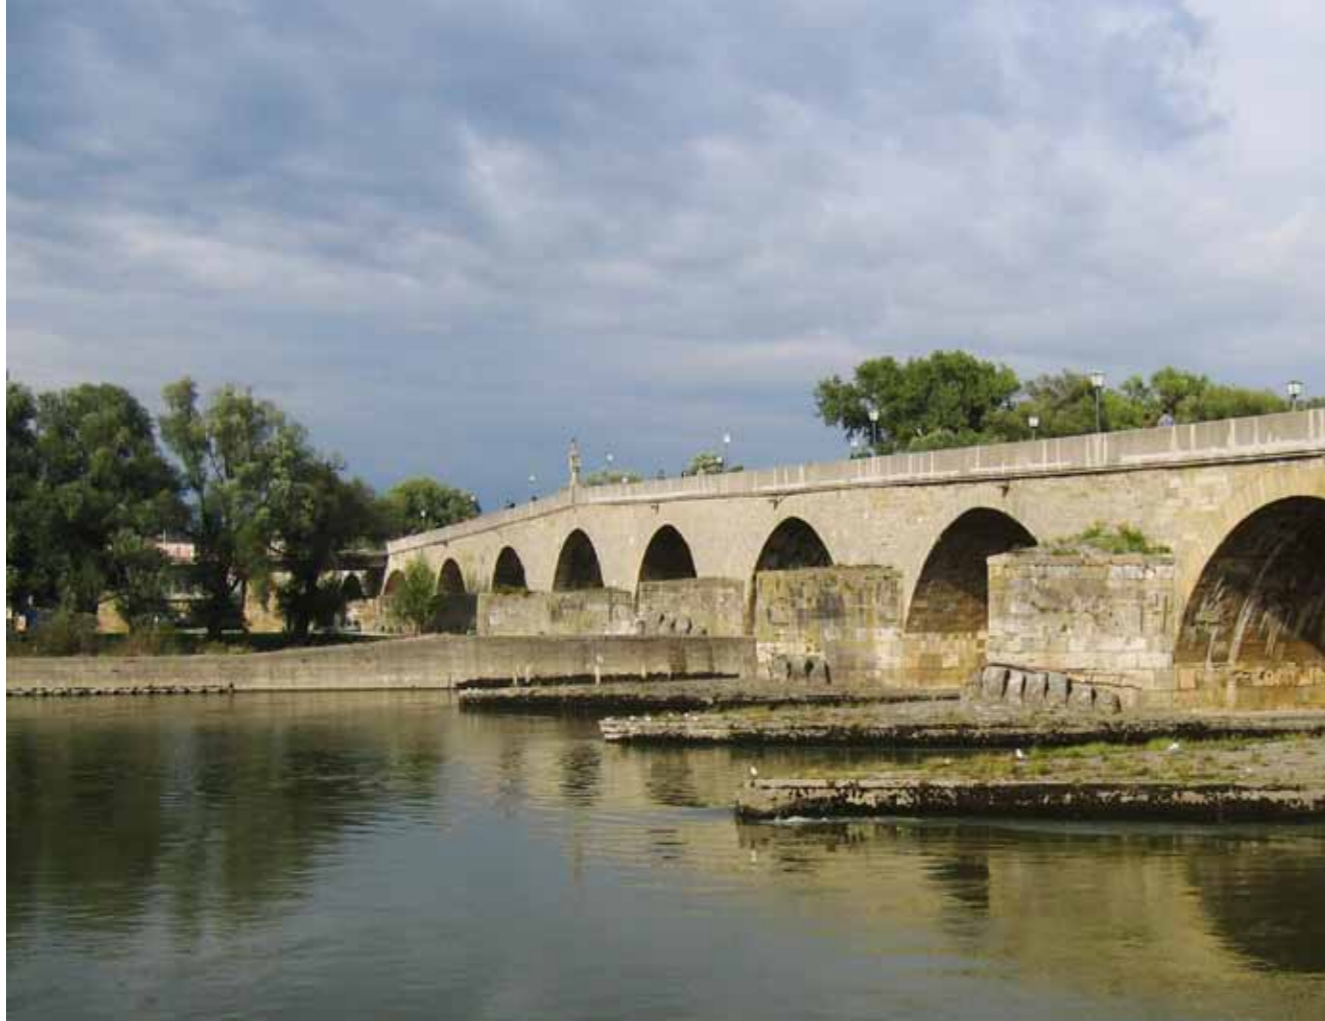
Figure 4.4.1.3: The stone arch bridge in Regensburg Source: C.Koepp.

The piers of the Old Stone Bridge in Regensburg, Germany are protected with cutwaters which were frequently jointed together by means of iron cramps (seen in Fig. 4.4.1.3 and Fig. 4.4.1.4). The outer stone ashlars of the cutwaters can be damaged or even extracted by ice friction, especially when the bridge is not maintained, and the stones can be released by growing vegetation. Regular and proper maintenance is therefore a basic and most important mitigation measure for protecting bridges from the adverse effects of floods.

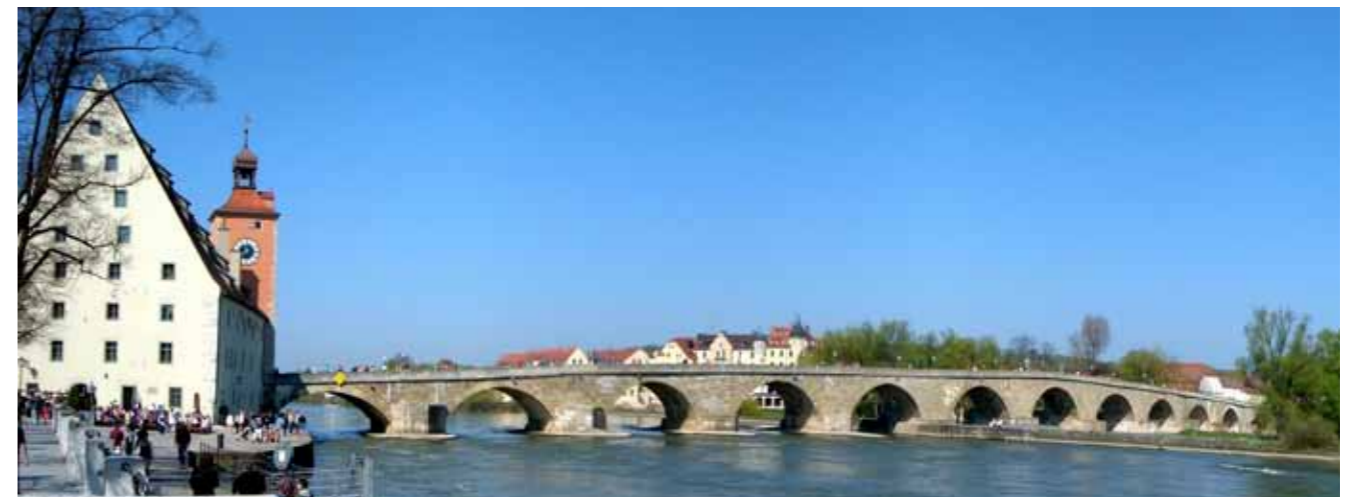
Figure 4.4.1.4: Protective stone-paved "islands" around the piers and cramps. Source: M. Drdácký.

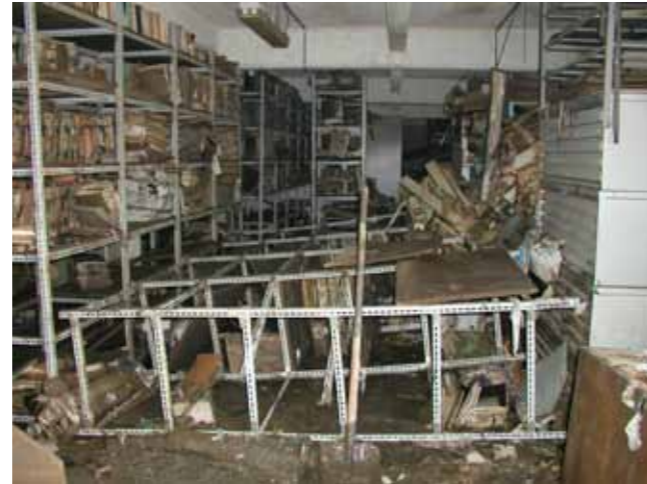
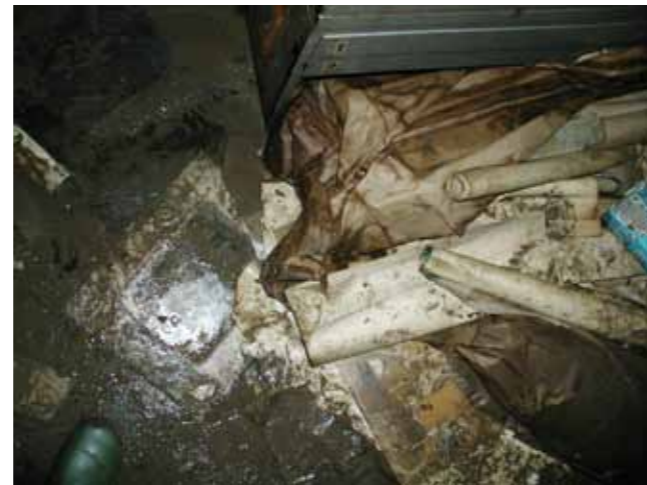
Figure 4.5.1.1: Archive of architectural plans in Prague after the 2002 flood. Source: NPŮ Praha.

The water level in the archive area reached a depth of 3,5 m. Collections of architectural plans, as well as archives of the aircraft industry, silver mines, Prague mechanical engineering factories and many other private collections, including photographic negatives from the period from 1880 until 1970, were immersed. 220 cubic metres of damaged materials were frozen immediately after the water relief. (Fig. 4.5.1.1)

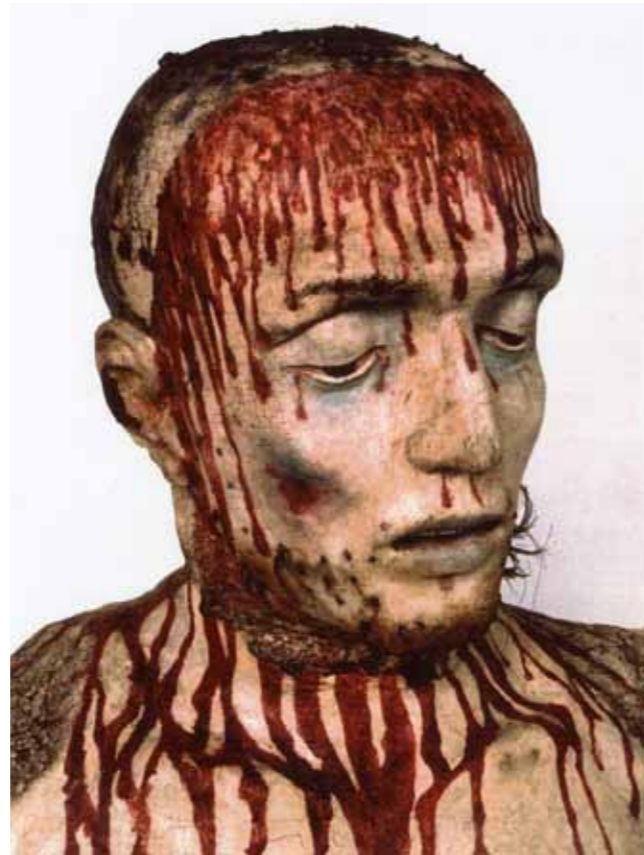
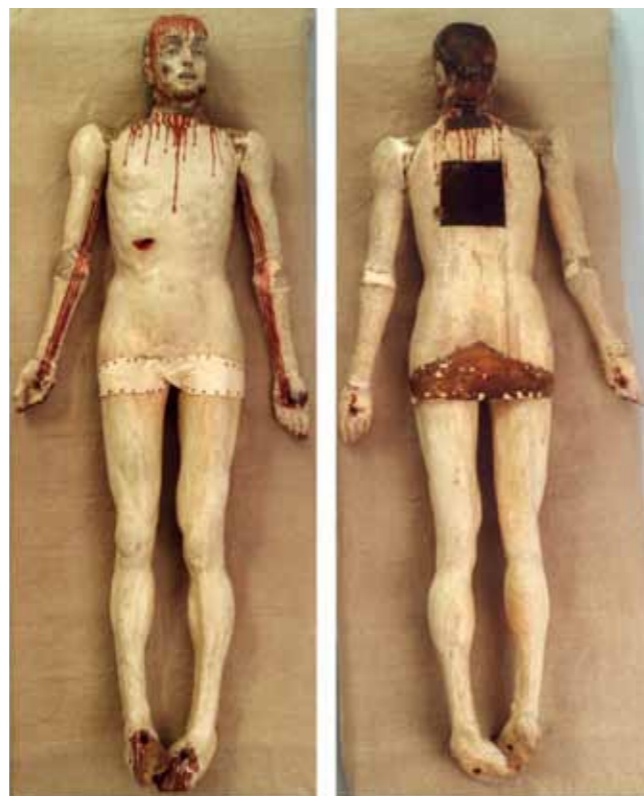
Figure 4.6.1.2: Photographs of the Miracle Man from the front and from the rear, and the head after restoration.  
Sources: Restauratorengemeinschaft J. Bösenberg, E. Kless and F. Wosnitza.

The figure is about life-sized, 1.95 m in height and with a span of 1.90 m. It is made of lime wood, and most parts of the body are massive. Only the head and the upper part of the body are hollow. The void space in the body contains a small vessel, which is connected to the wound in the chest. The vessel was used to release red liquid simulating a bleeding injury during processions (see Fig. 4.6.1.2).

The restoration has achieved a very good outcome, scarcely distinguishable from the condition before the devastating flood (see Fig. 4.6.1.2). Only the shape of the sculpture has changed slightly, due to the influence of the water. The leather joints are now completely immovable.

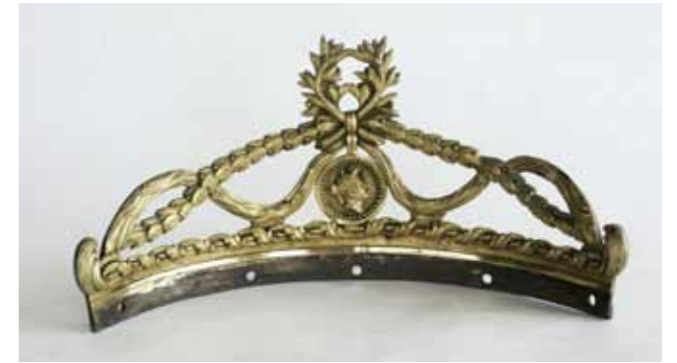
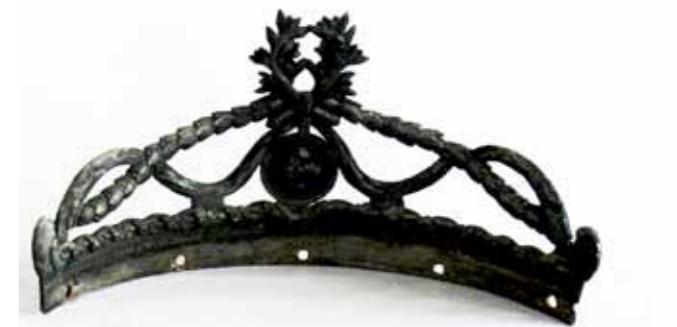
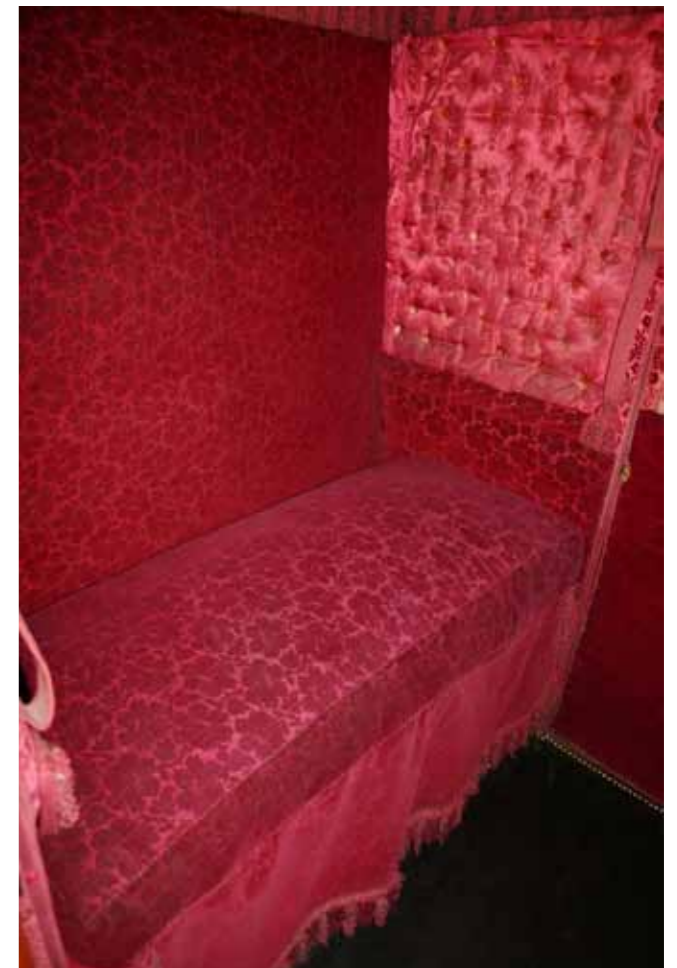
Figure 4.6.2.1: Metal parts after restoration (upper), and before restoration (lower). Source: Karel Poupě.

Figure 4.6.2.2: Archbishop's carriage (see next page) and Silken velvet after restoration. Source: Alena Grendysová.

The metal parts of the carriage include iron, steel and gilt bronze. They were soiled with remnants of diluvial mud, and were corroded, deformed, with mechanically damaged polychromy after previous dismantling and repairs, and were heavily contaminated, namely the bronze parts, Fig. 4.6.2.1.

The textile parts were made of pressed silken velvet decorated with flower ornamentation (carriage interior). They suffered from mould formation and from mechanical damage to the braids, and they exhibited total devastation (Fig. 4.6.2.2)

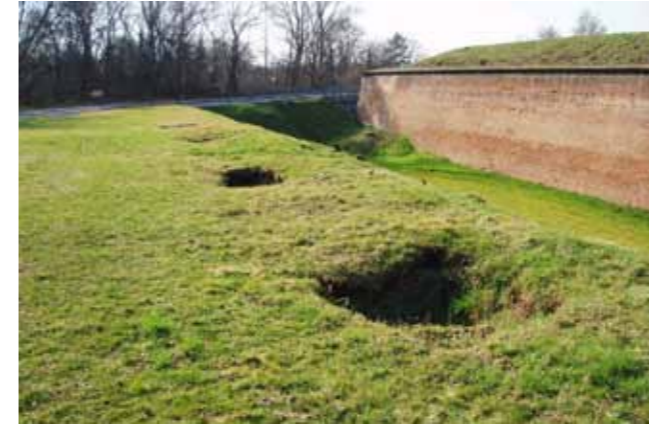
Figure 4.7.1.4: Sunken soil over a failed vault. Source: Roman Gazsi.

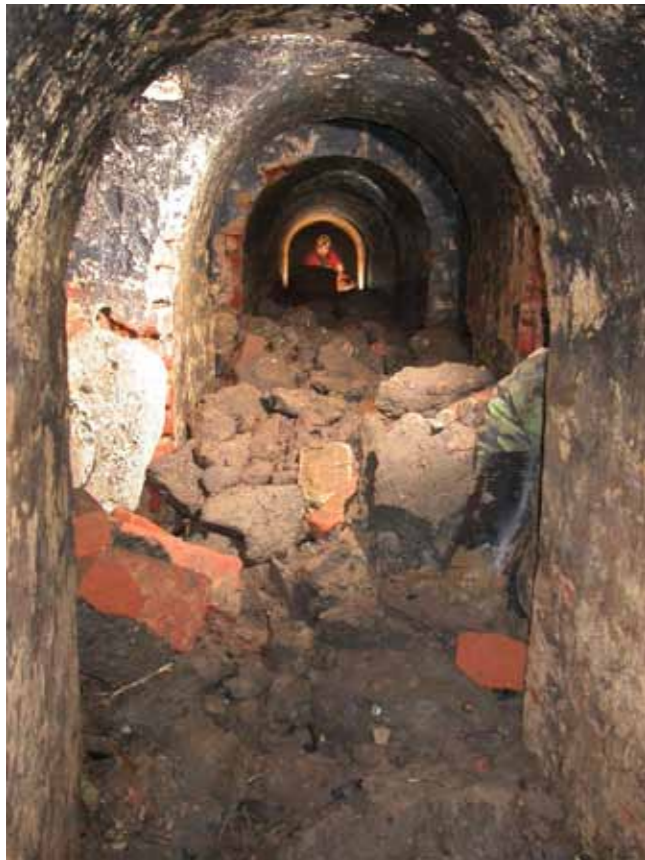
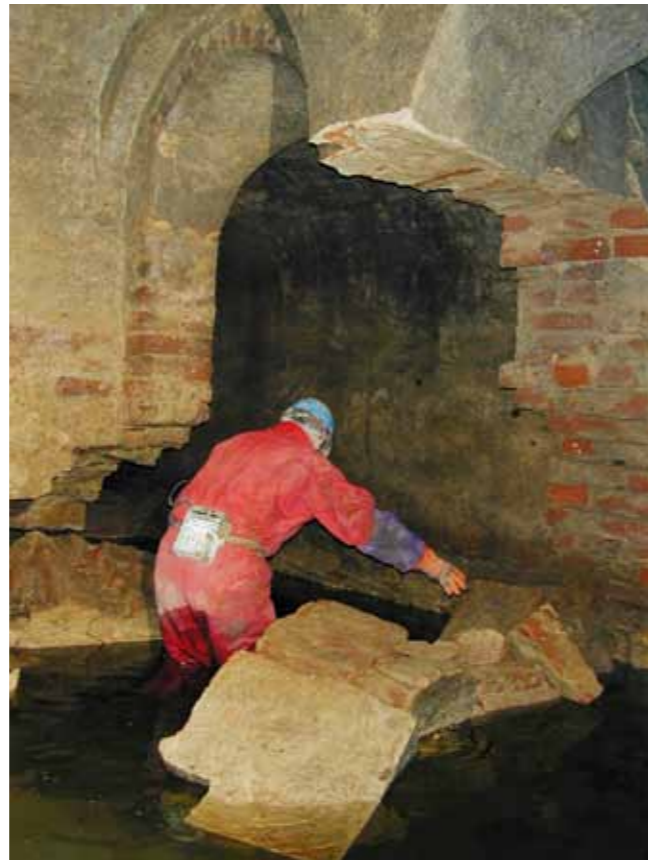
Figure 4.7.1.3: Underground corridors caved with mud and brick (left part), collapsed walls and columns of underground channels. Source: Roman Gazsi.

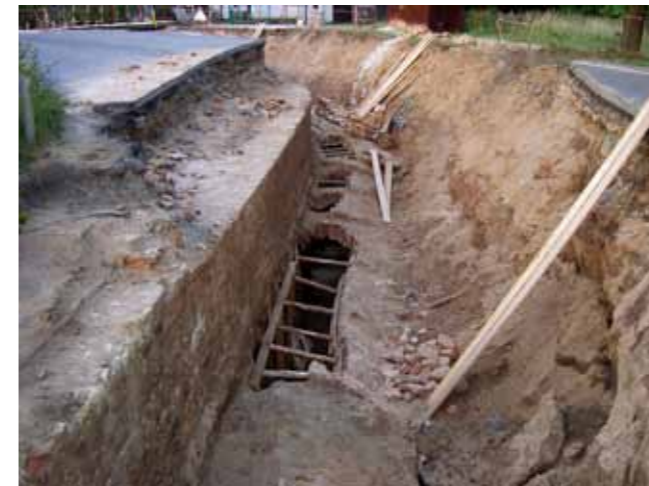
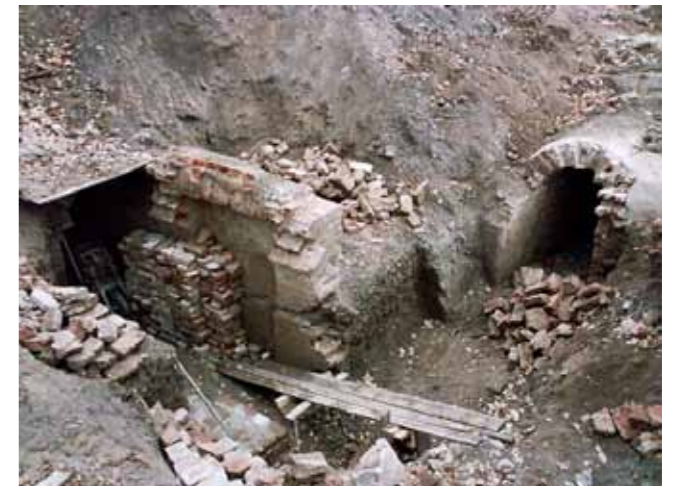
Figure 4.7.1.5: Repairs to shallow mine corridors (left), and to damaged vaults (right). Source: Roman Gazsi

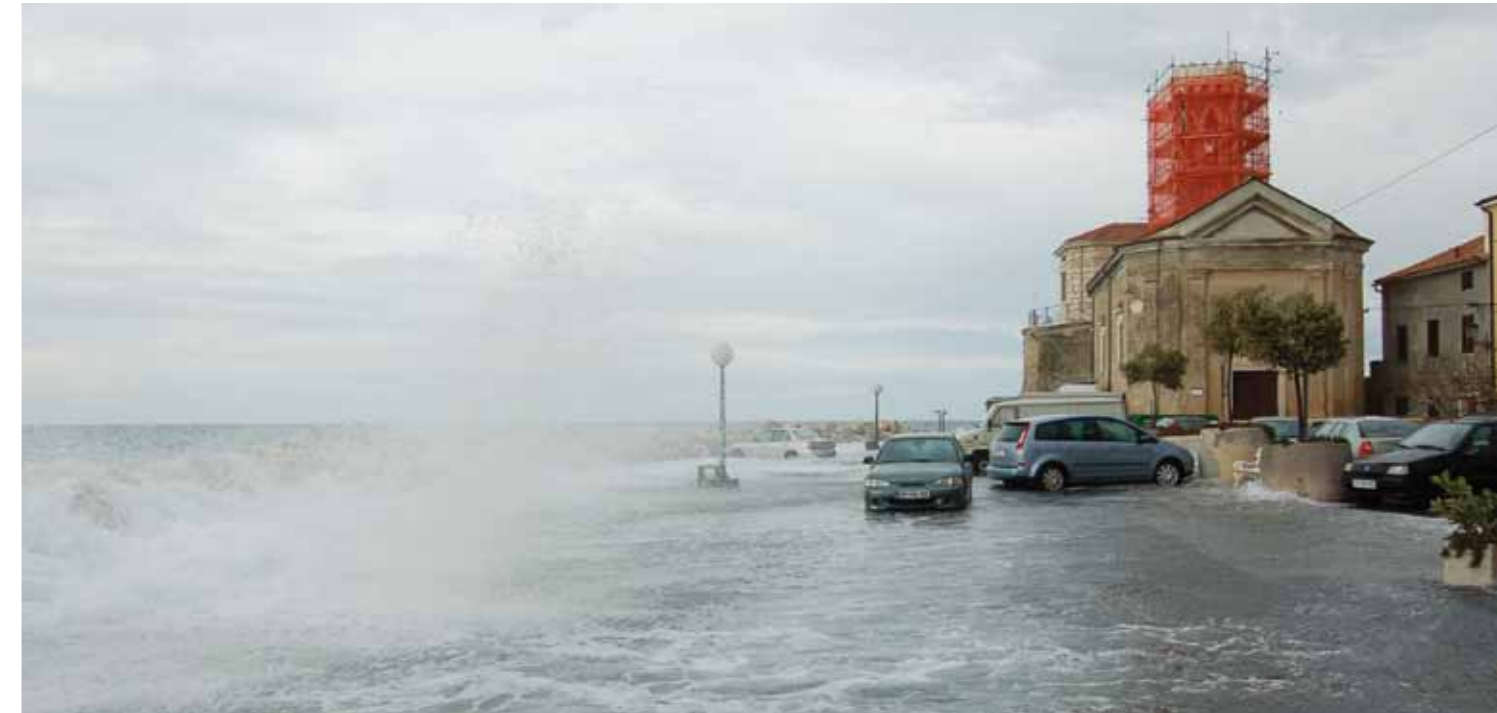
Figure 4.7.2.4: Sea water, accompanied by salty mist, washing on to the walkway which separates the church of Our Lady of Health in Piran from the sea. Source: ZAG

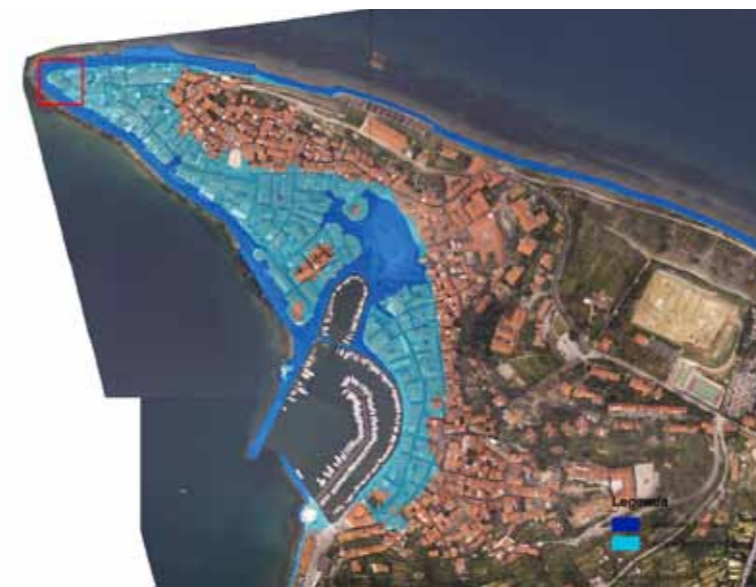
Figure 4.7.2.3: Enlarged section of the above map, representing the Piran peninsula with yearly (dark blue) and extreme (light blue) flood areas (2006). Source: Kolega.

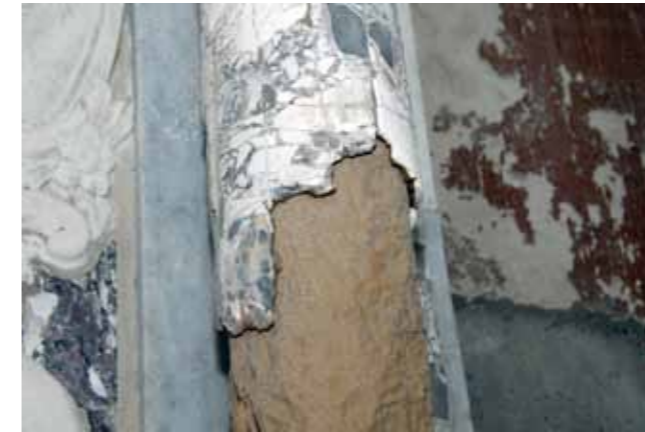
Figure 4.7.2.5: The elaborate work of Venetian stonemasons has deteriorated into fragments. Source: ZAG.

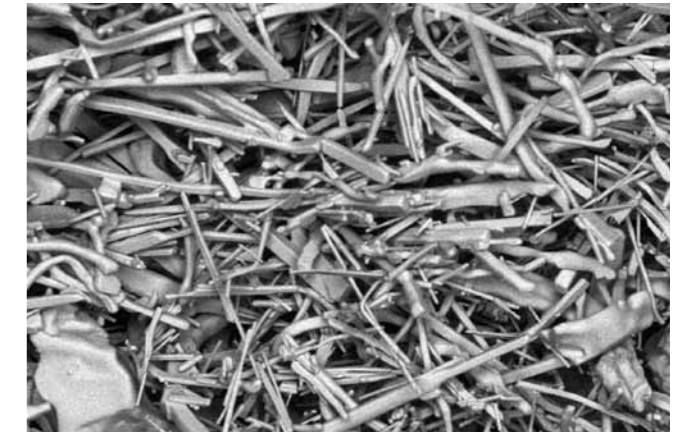
Figure 4.7.2.6: Lengthy needle-like halite crystals are the most frequent cause of degradation of the materials inside the church. Source: ZAG.

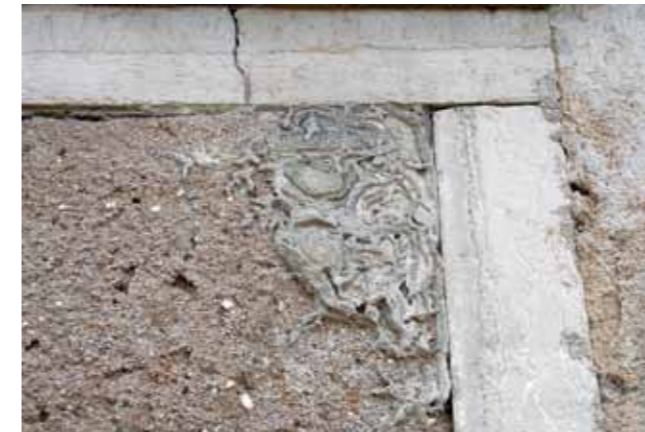
Figure 4.7.2.7: Sulphate corrosion of the façade plaster. Source: ZAG.

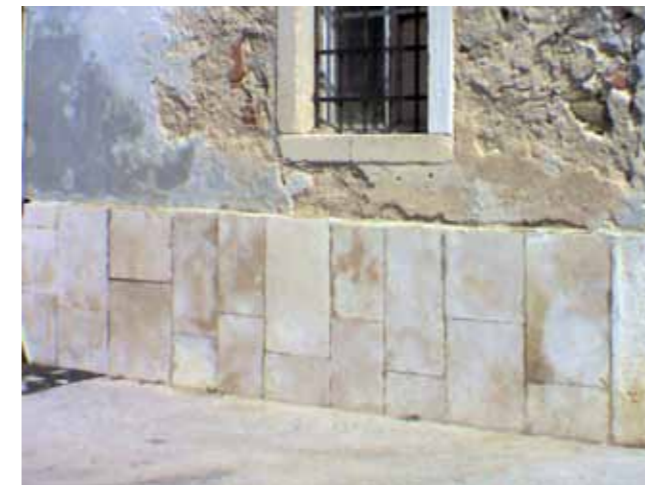
Figure 4.7.2.9: Degradation of the façade plaster on the west façade, caused by the capillary rise of groundwater. Source: ZAG

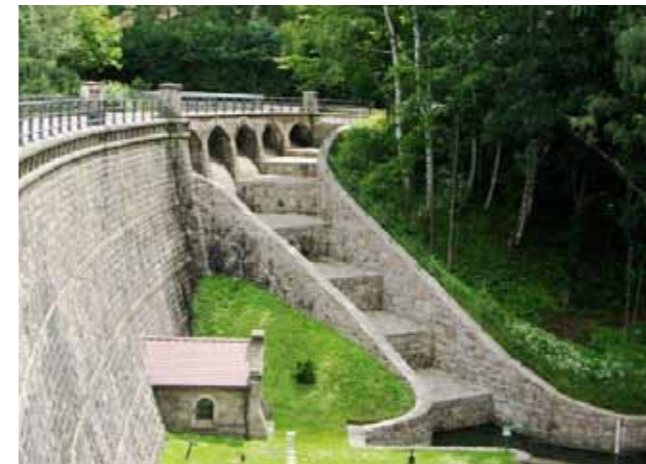
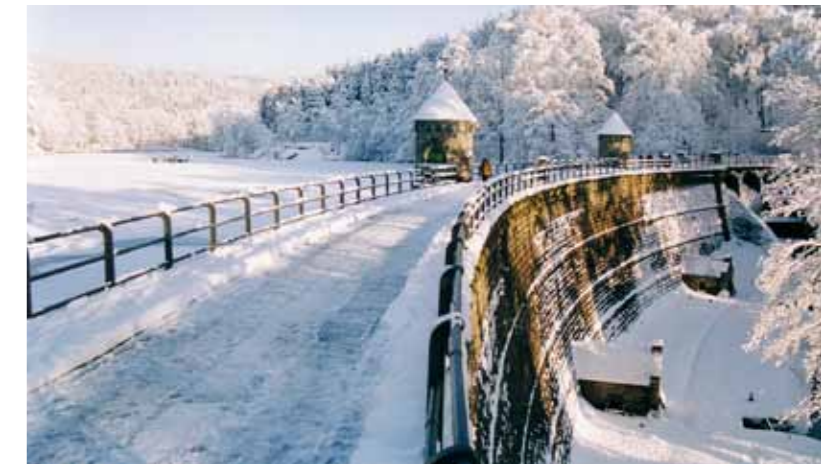
Figure 4.7.3.1: Harcov dam in winter, and the spillway with a cascade.  
Sources: J. Pikous, M. Zukal.

The dam comprises the retaining structure, two outlets (2x DN 800), a small water power station, a chute spillway and some other facilities. The retaining structure is an Intze-type gravitation dam walled up as stone masonry. Its layout line is curved, with a radius of 120 m, and its height above the foundation level reaches 19 m. The through chute spillway is situated on the left bank and it is composed of five bays each 5 m in width. The spillway continues with a cascade of 7 steps varying in height between 0,6 m and 1,2 m, Fig. 4.7.3.1.

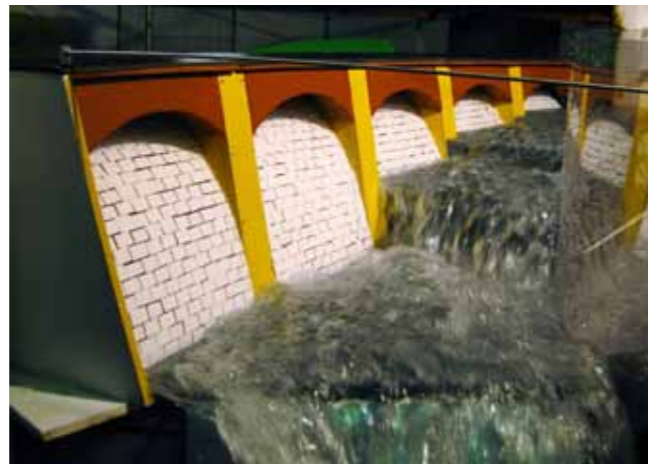
Figure 4.7.3.3: Water flow over the cascade in the model. Source: Milan Zukal.

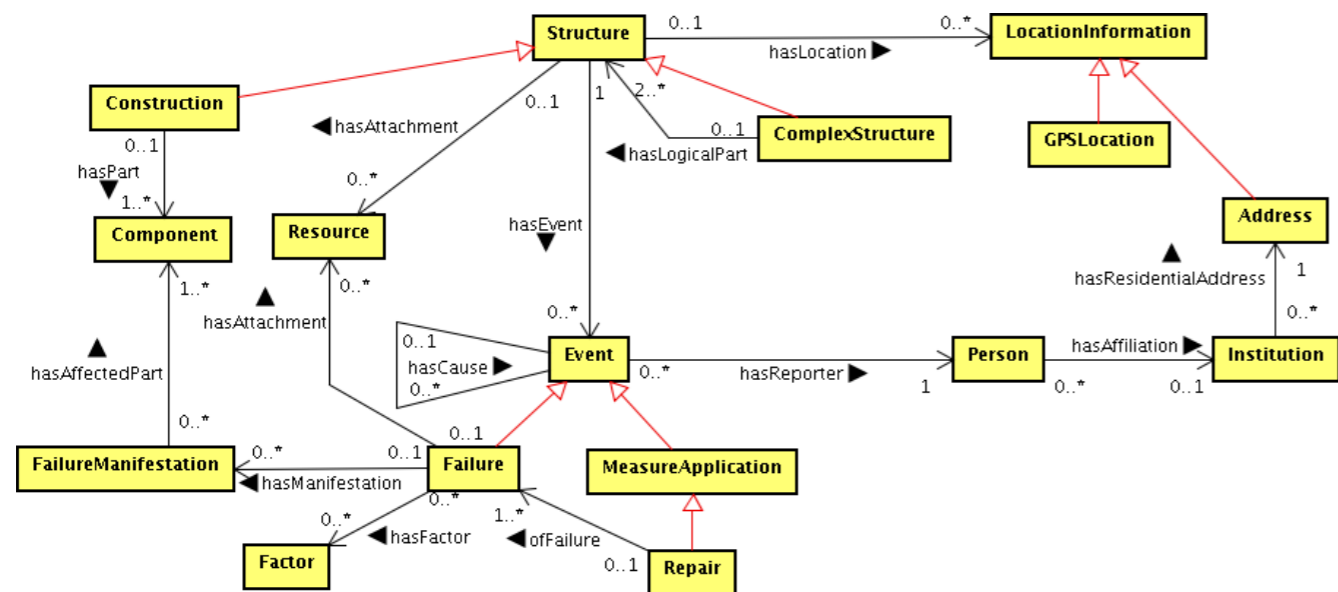
Figure 7.2.1: Basic structural relations between structures, failures and related information. Classes are shown as yellow rectangles, hierarchical information is represented by red arrows, and property associations are shown as black arrows. Numbers on arrows represent cardinalities - i.e. Structure can have assigned zero or many events (hasEvent 0..\*), but each event (e.g. failure) must be assigned to exactly one structure (hasEvent 1). Source: J. Valach

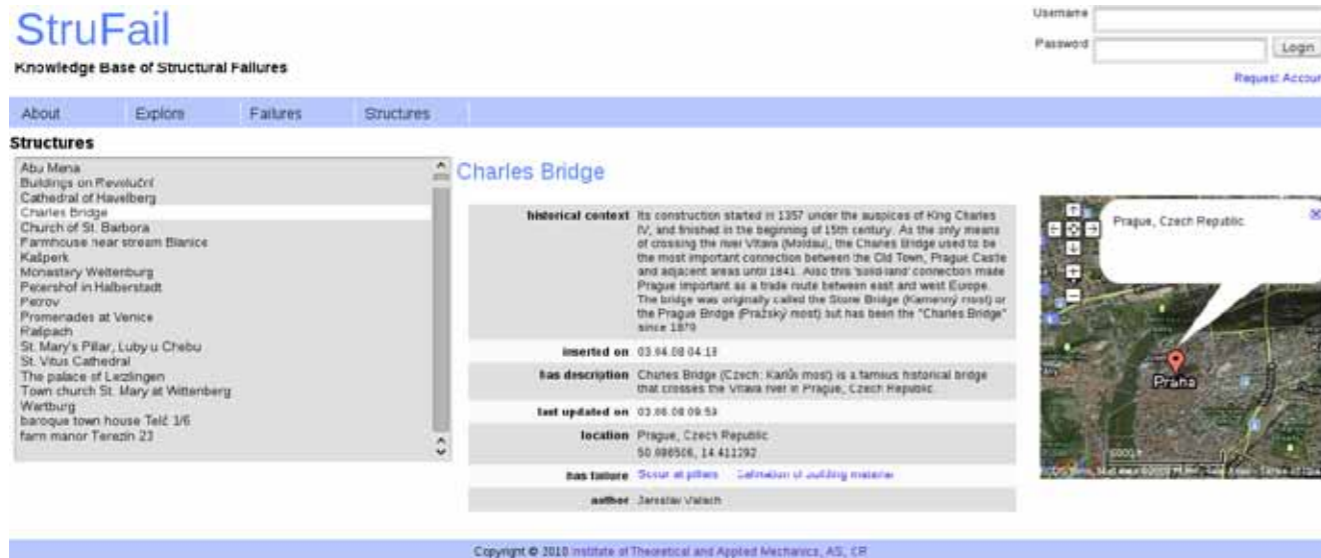
Figure 7.2.3: Basic user interaction including exploration of damaged structures (menu Structures), their attributes, location on Google Maps and assigned failures. Source: J. Valach.

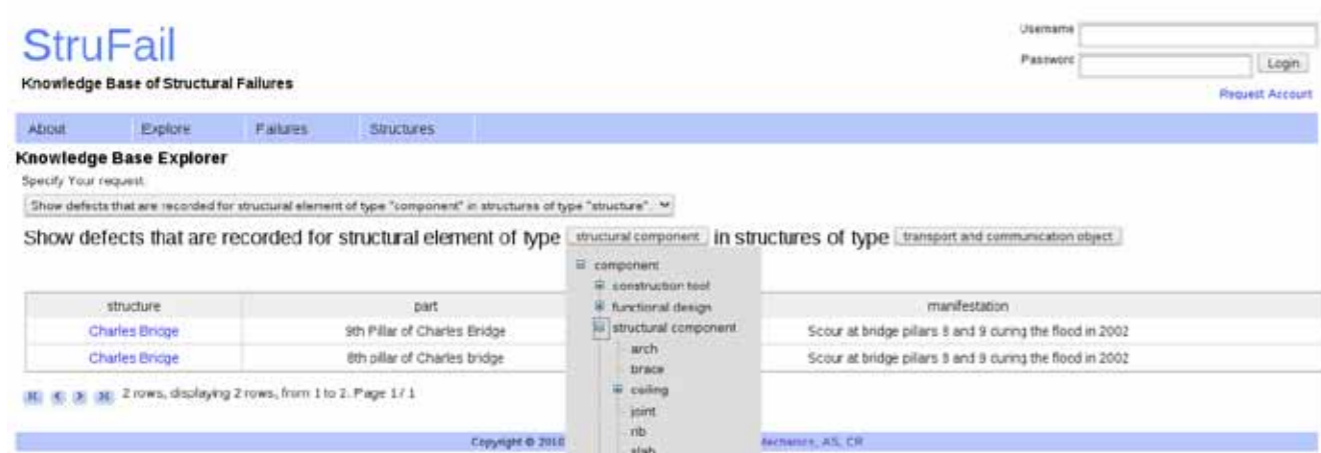
Figure 7.2.4 Exploration of the knowledge base by predefined queries. Source: J. Valach.

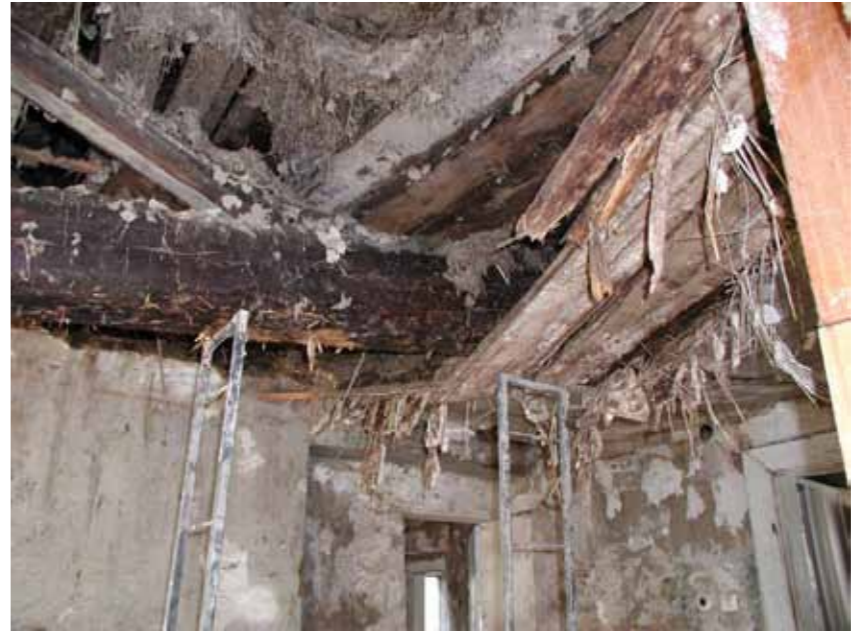
<p><b>Cause of failure:</b>  Long term immersion in floodwater, which covered the roof ridge and saturated the debris ceiling infill, overloading the structure with deteriorated and weakened timber joists – caused by ligniperdous insects.</p>
<p><b>Important parameters for the failure analysis:</b>  Flood data, material characteristics of timber, structural dimensions and loads, moisture of timber.</p>
<p><b>Remedial works:</b>  During the flood the masonry with only clay mortar, without any lime binder or cement, was partially destroyed, and its stability was substantially reduced. Therefore the authorities agreed for the whole building to be demolished and replaced by a reconstruction.</p>
<p><b>Prevention:</b>  Special maintenance reducing overloading risks (attic and infill materials with low saturation) and water degradation effects, clay mortar stabilisation and consolidation, temporary strengthening of ceiling joists.</p>

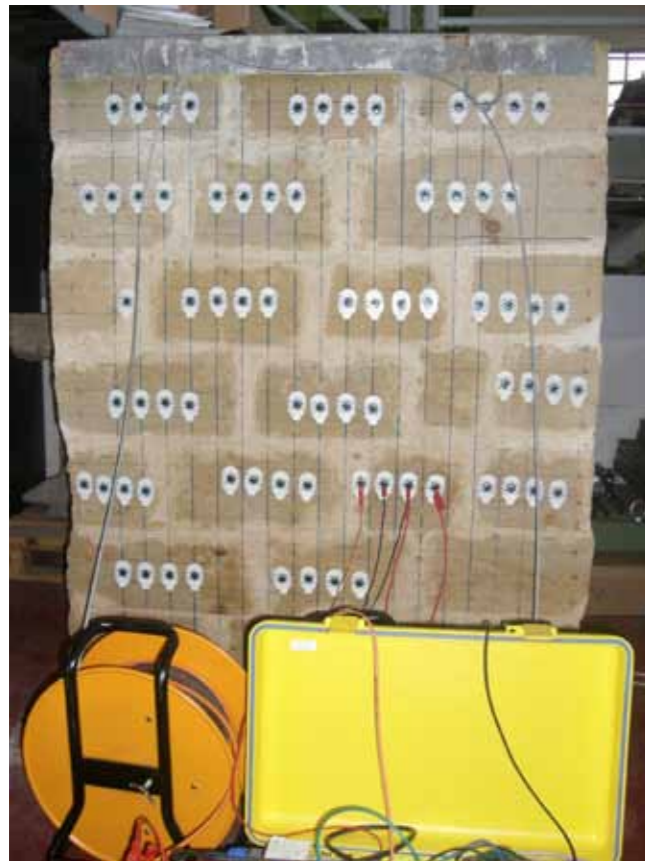
Figure 7.4.2.1: Field size CR measurements on a sandstone testing wall (left). Ordinary medical ECG electrodes are used. This picture shows a four-point Wenner setup. The water distribution was investigated after the wall was flooded for about a week. The results of Wenner ( $a = 5$  cm) measurements of electrical resistivity obtained on single stones are shown on the right. Source: BAM.

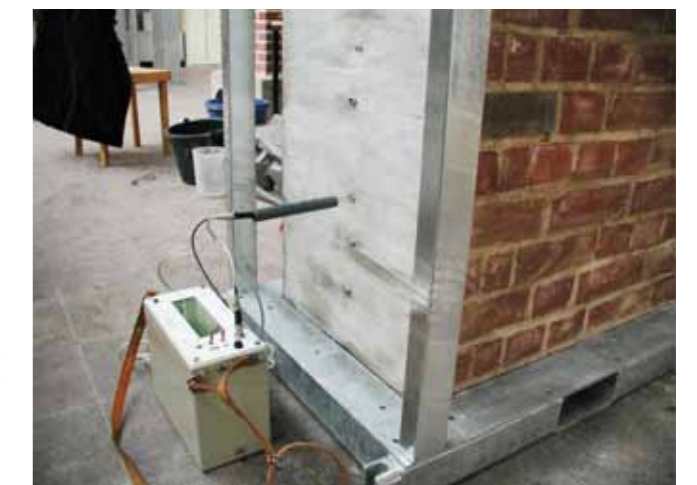
Figure 7.4.2.4: Left: Schematic diagram of a 2-rod probe consisting of two parallel metal rods of defined length. At discontinuities such as the beginning and the end of the metal bars the electromagnetic pulse is reflected. ( $t_0$ ,  $t_1$  und  $t_2$ ). The signals are depicted for both a step pulse (grey) and a sine-shaped peak pulse (black). Source: Plagge (2003). Right: Photograph of the TDR technique being applied to a masonry specimen. Source: BAM.

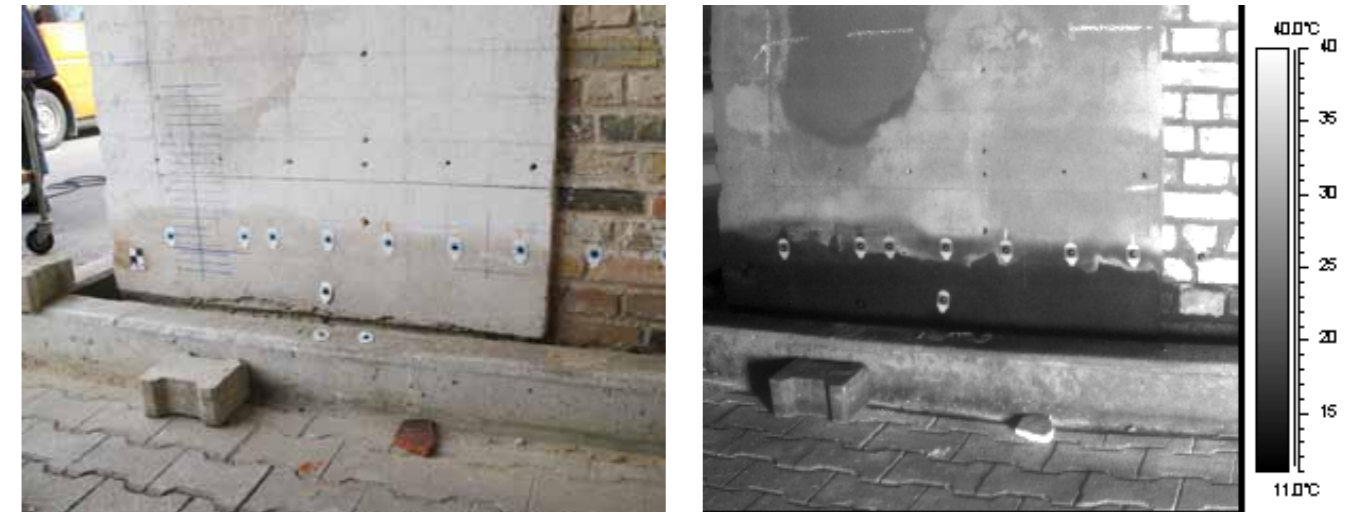
Figure 7.4.3.1: Photograph of a brick masonry specimen section partly covered with plaster (left). The specimen is contained in a concrete basin and was flooded with tap water. In the reflection thermogram recorded after 5 min. of heating, two moisture horizons can be clearly differentiated (right). Source: BAM.

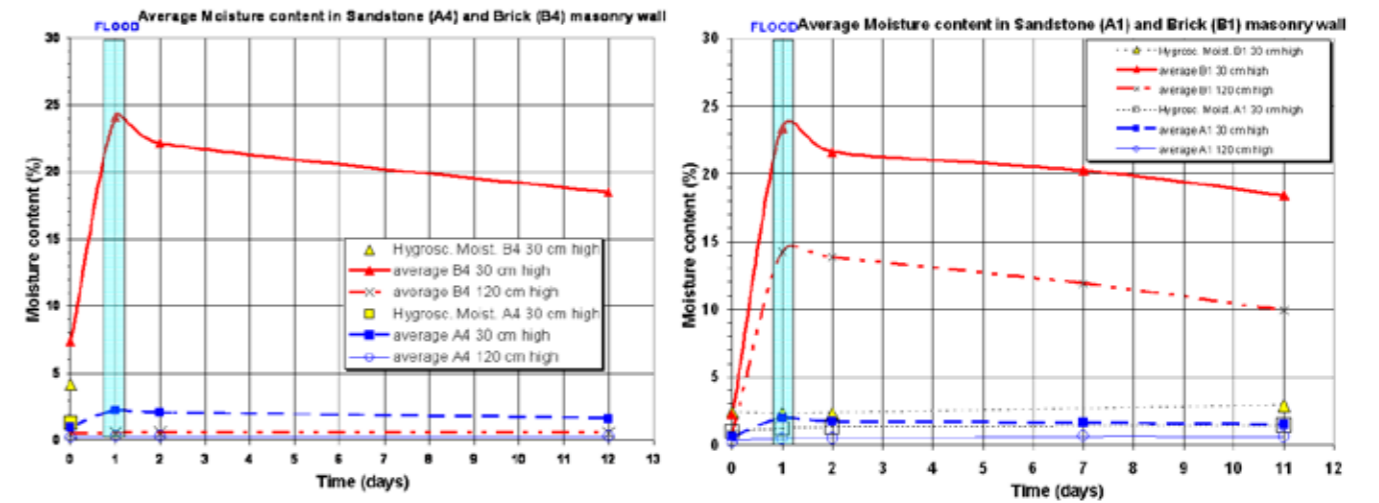
Figure 7.5.14: Moisture content by the powder drilling test in time, during the drying process, at heights of 30 cm and 120 cm of untreated masonry walls A4 and B4 and of treated masonry walls A1 and B1. Source: Polimi.
