Cultural Heritage Protection against Flooding

Miloš Drdáček, Luigia Binda, Insa Christiane Hennen, Christian Köpp, Luca G. Lanza and Rosemarie Helmerich

CHEF provides knowledge about flood protection of cultural heritage objects and directly supports the European Floods Directive by giving recommendations on how to assess the vulnerability of monuments. A comprehensive analysis of protective measures BEFORE, DURING and AFTER a flood has been carried out within the project, including technical and administrative measures. An overview of these measures is given, followed by recommendations on how to establish the most effective protective strategies.

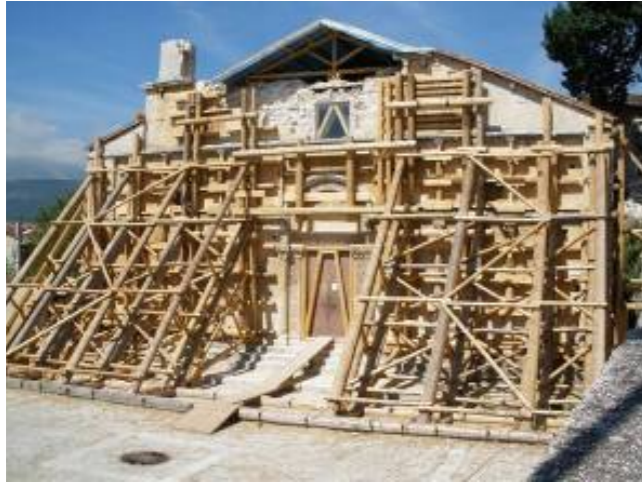
Figure 7.7.2: Traditional provisional structures for an emergency situation. Source: POLIMI.

Provisional interventions for the safety of facades can be performed in one of two ways: through traditional propping systems using wooden poles (Fig. 7.7.2), or through tying, with the use of steel cables or polyester bands (Fig. 7.7.3). These two types of intervention involve different structural approaches: the first approach is intended to partially restore the stiffness of the structure, while in the second latter approach, the bands (or the ties) elastically connect the different stiff blocks detected by the activation of the seismic damage and that form the kinematic chain (Bellizzi, 2000). Preference is given to the second method, because it is more practical and does not block access. Interventions performed with traditional props occupy a large area of ground in front of the facade for placing the poles, thus preventing passage. Interventions performed with bands or ties occupy the ground in front of the building only to a minimal extent. In addition, they are quicker to apply and to remove. From a structural point of view, interventions with bands or ties connect the rigid blocks identified by cracks caused by the earthquake. The damaged structure has lower overall stiffness than it had in its pre-earthquake condition, and exact positioning of the bands provides a great displacement capacity and can prevent collapse due to overturning.

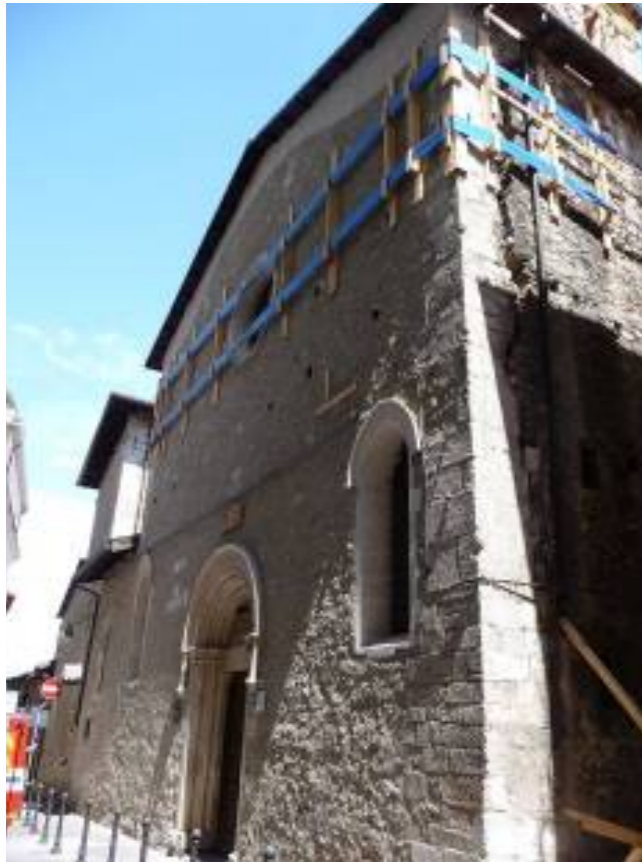
Figure 7.7.3: New provisional structures for an emergency situation. Source: POLIMI.
